**LA SALLE REDBOINE CONSERVATION DISTRICT:
LA SALLE RIVER WATERSHED ASSESSMENT SURVEY – WITH
EMPHASIS ON LA SALLE RIVER, ELM RIVER, ELM CREEK
CHANNEL, AND THE KING DRAIN - 2005**

P. G. Graveline and J. Larter

2006

North/South Consultants Inc.
Aquatic Environment Specialists

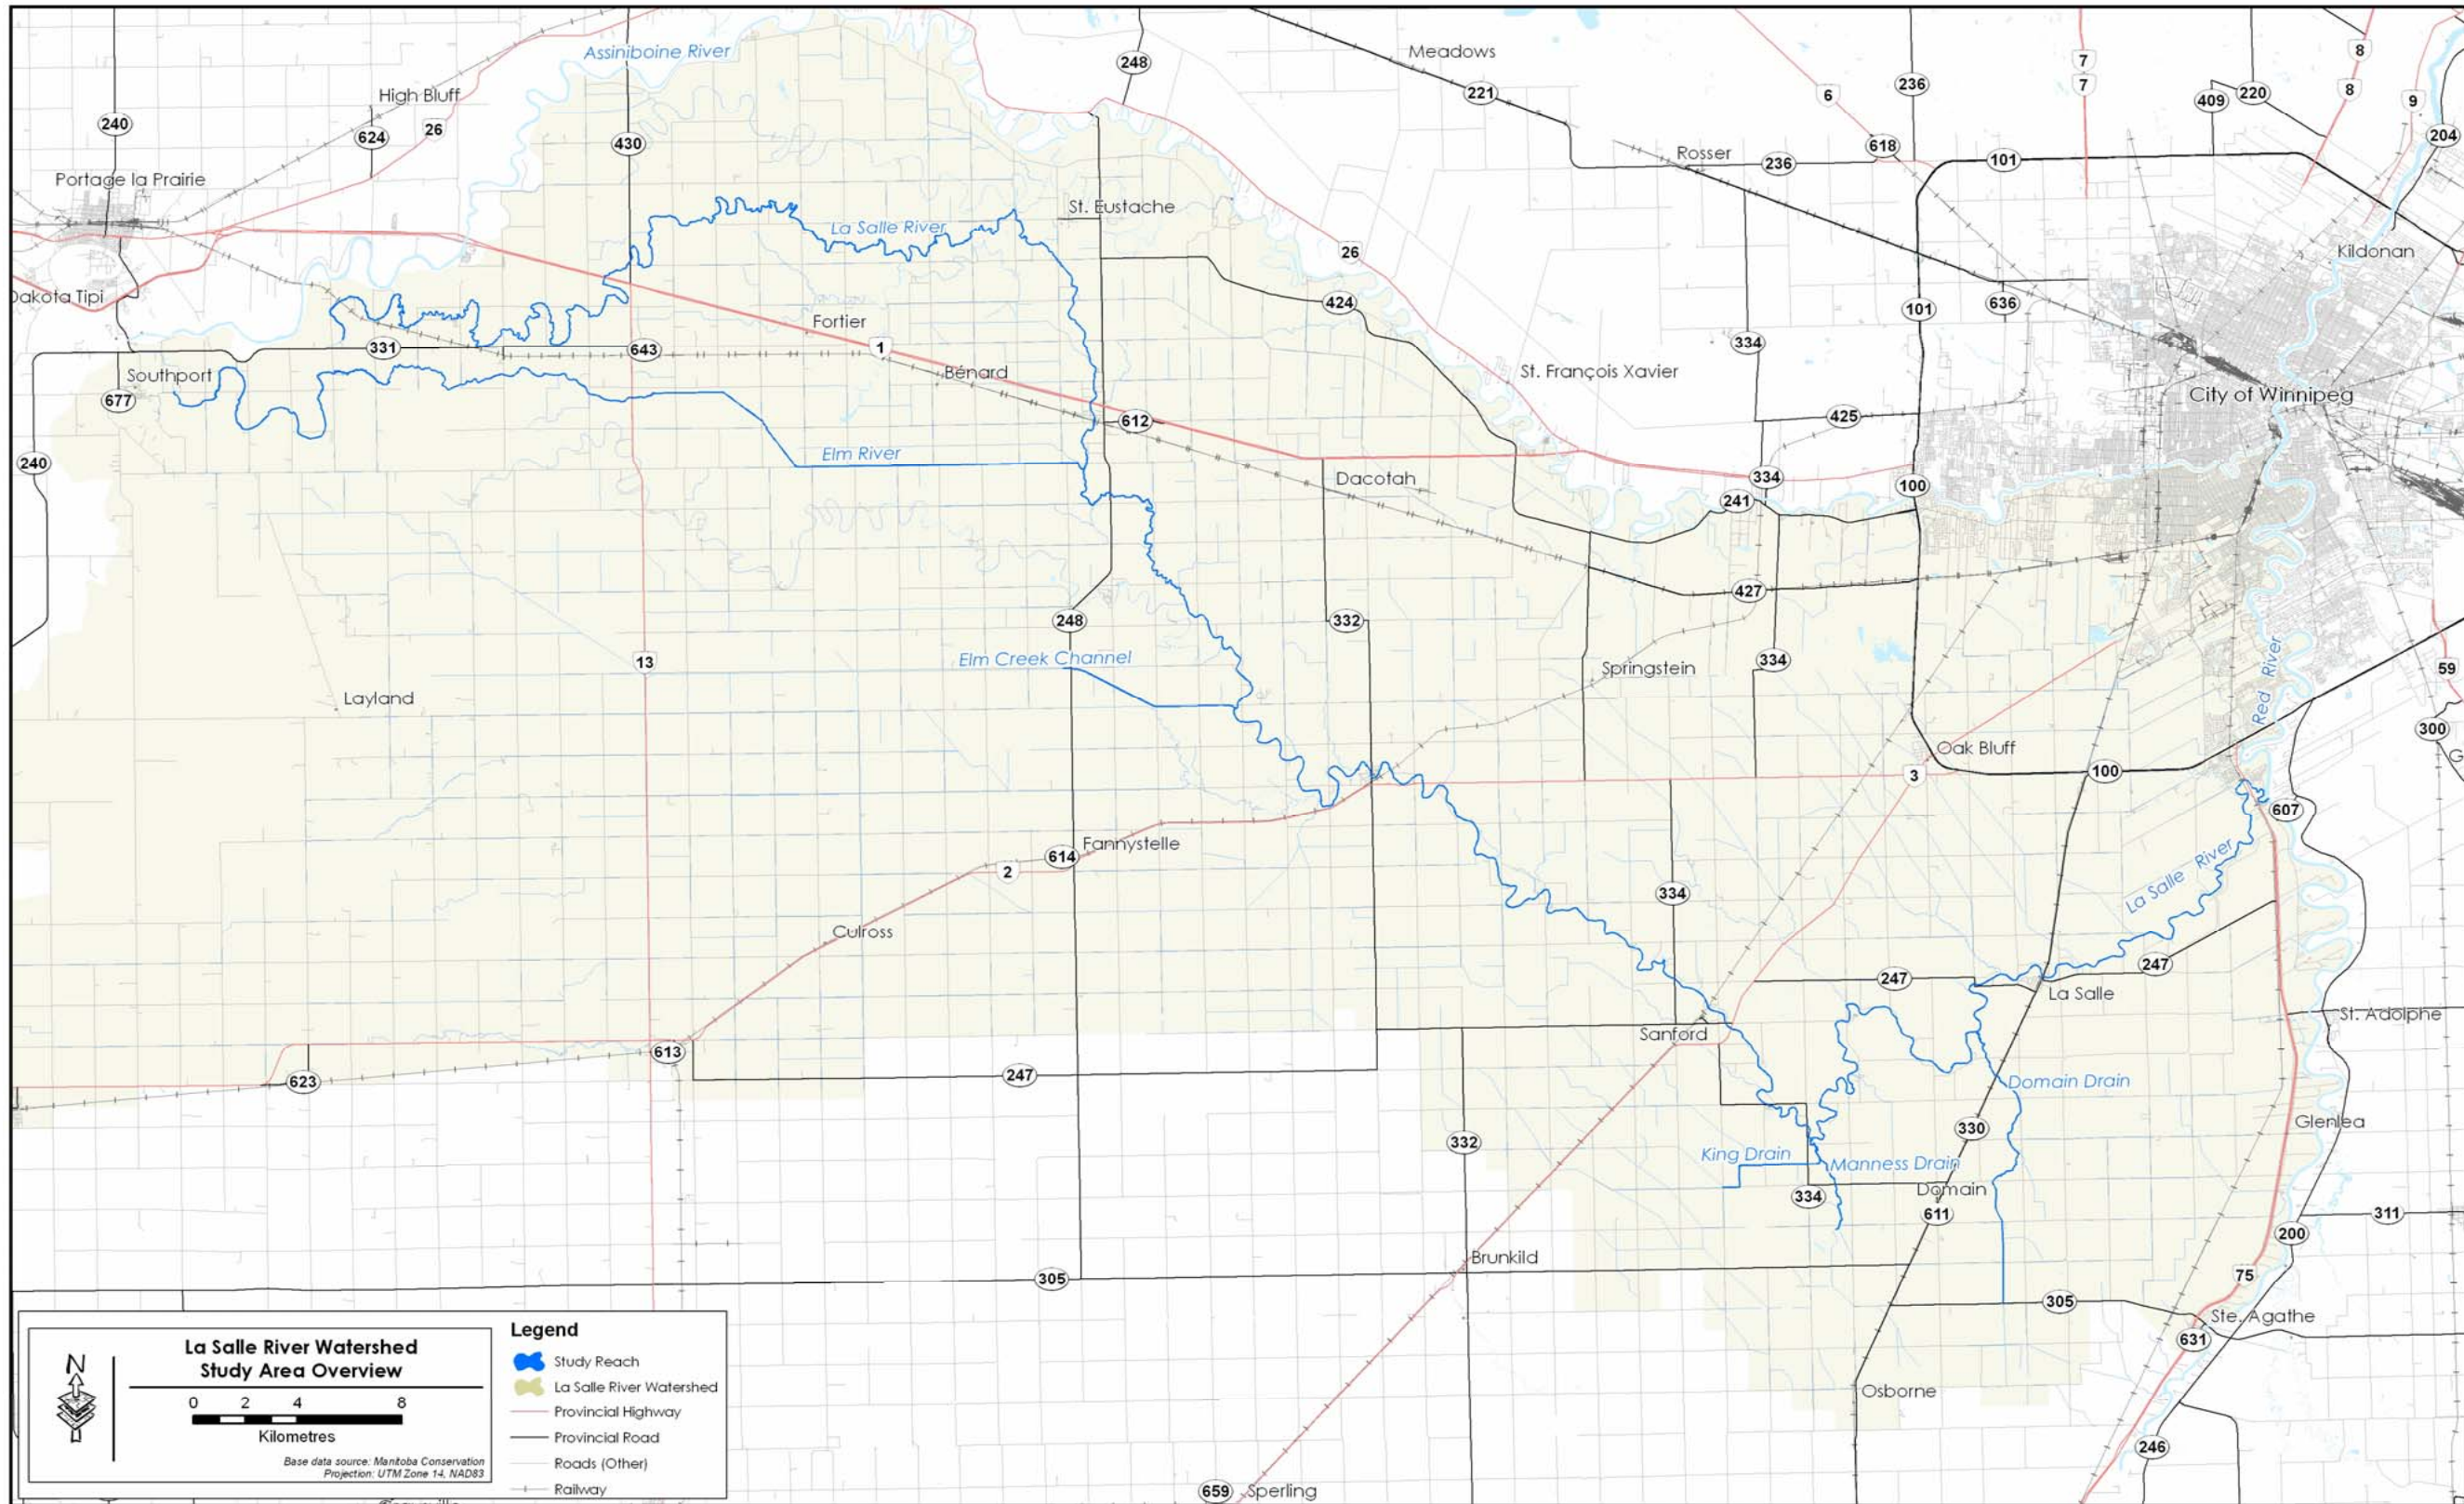
Figure 1. La Salle River watershed study area, 2005.

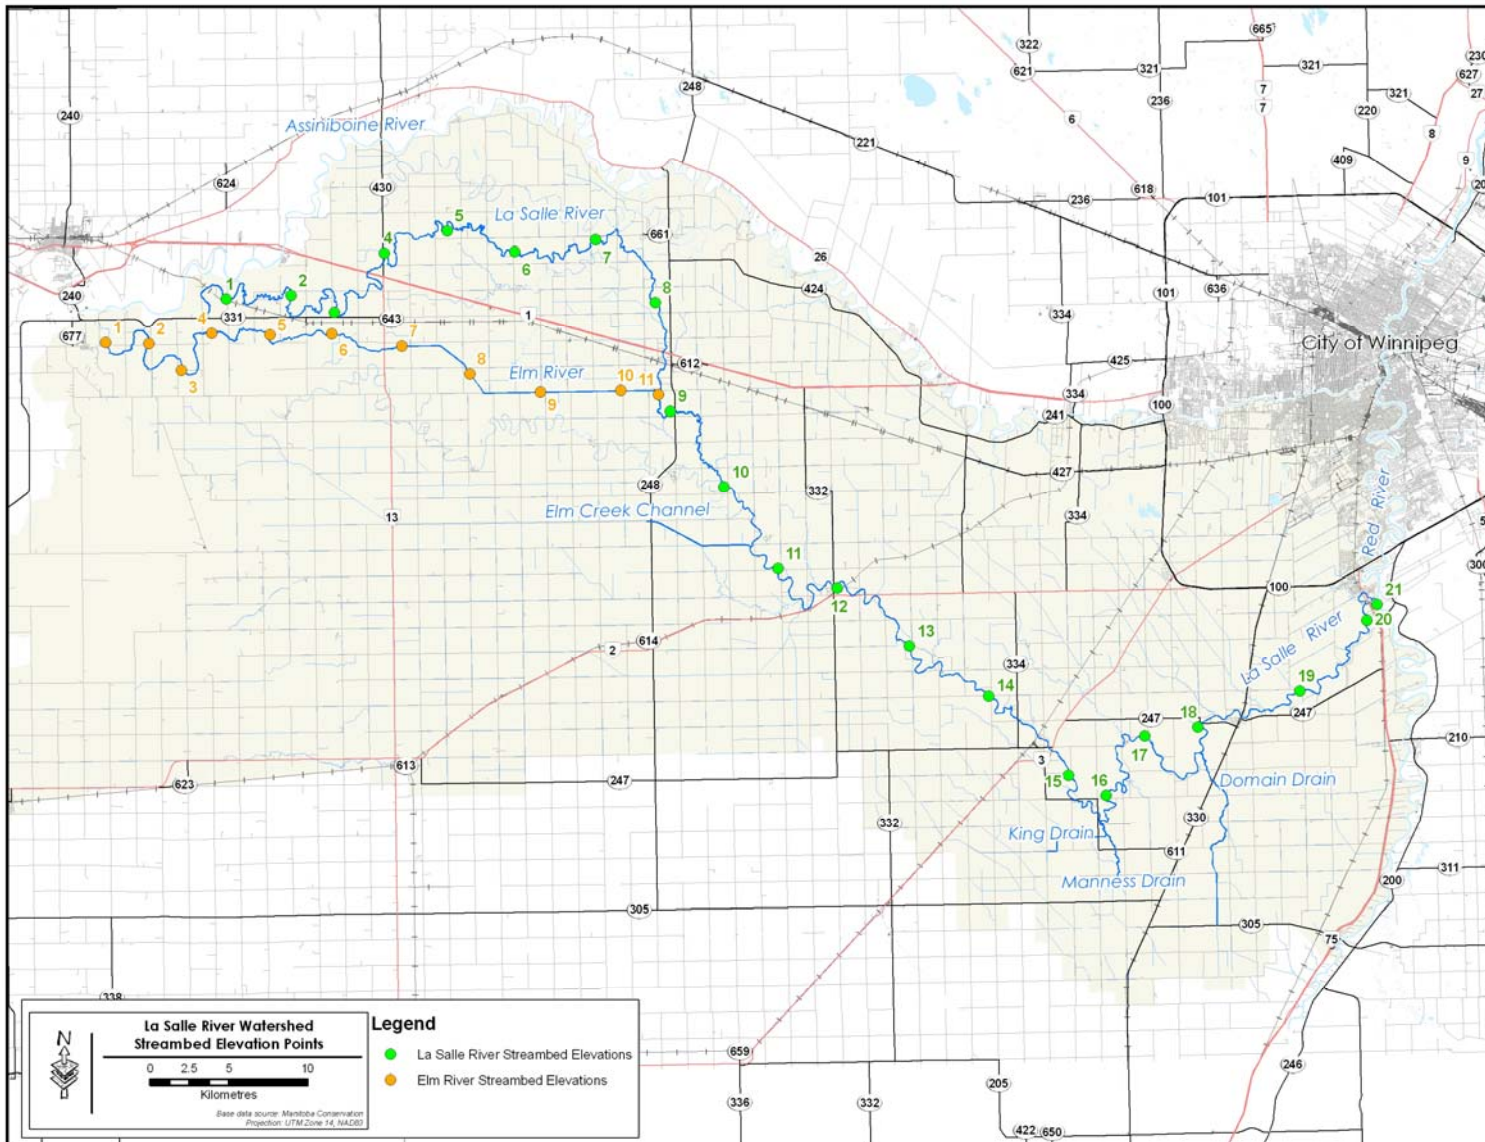
Figure 2. Identification points used to generate longitudinal stream bed profiles along the La Salle and Elm rivers, 2005.

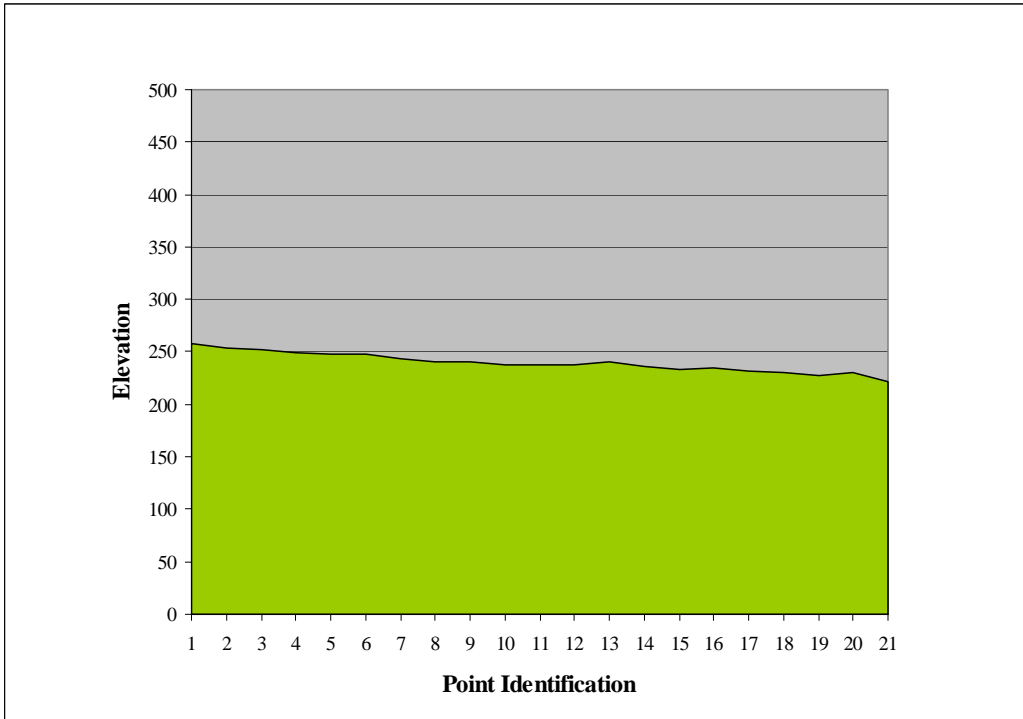
Figure 3. Longitudinal streambed profile of the La Salle River (elevation in masl).

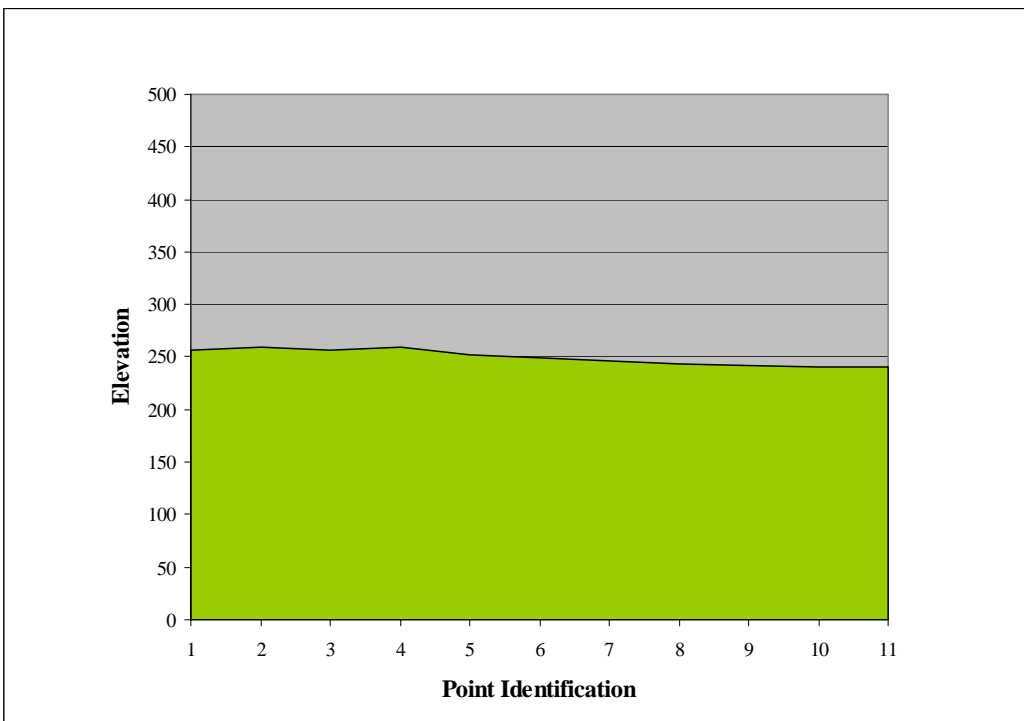
Figure 4. Longitudinal streambed profile of the Elm River (elevation in masl).

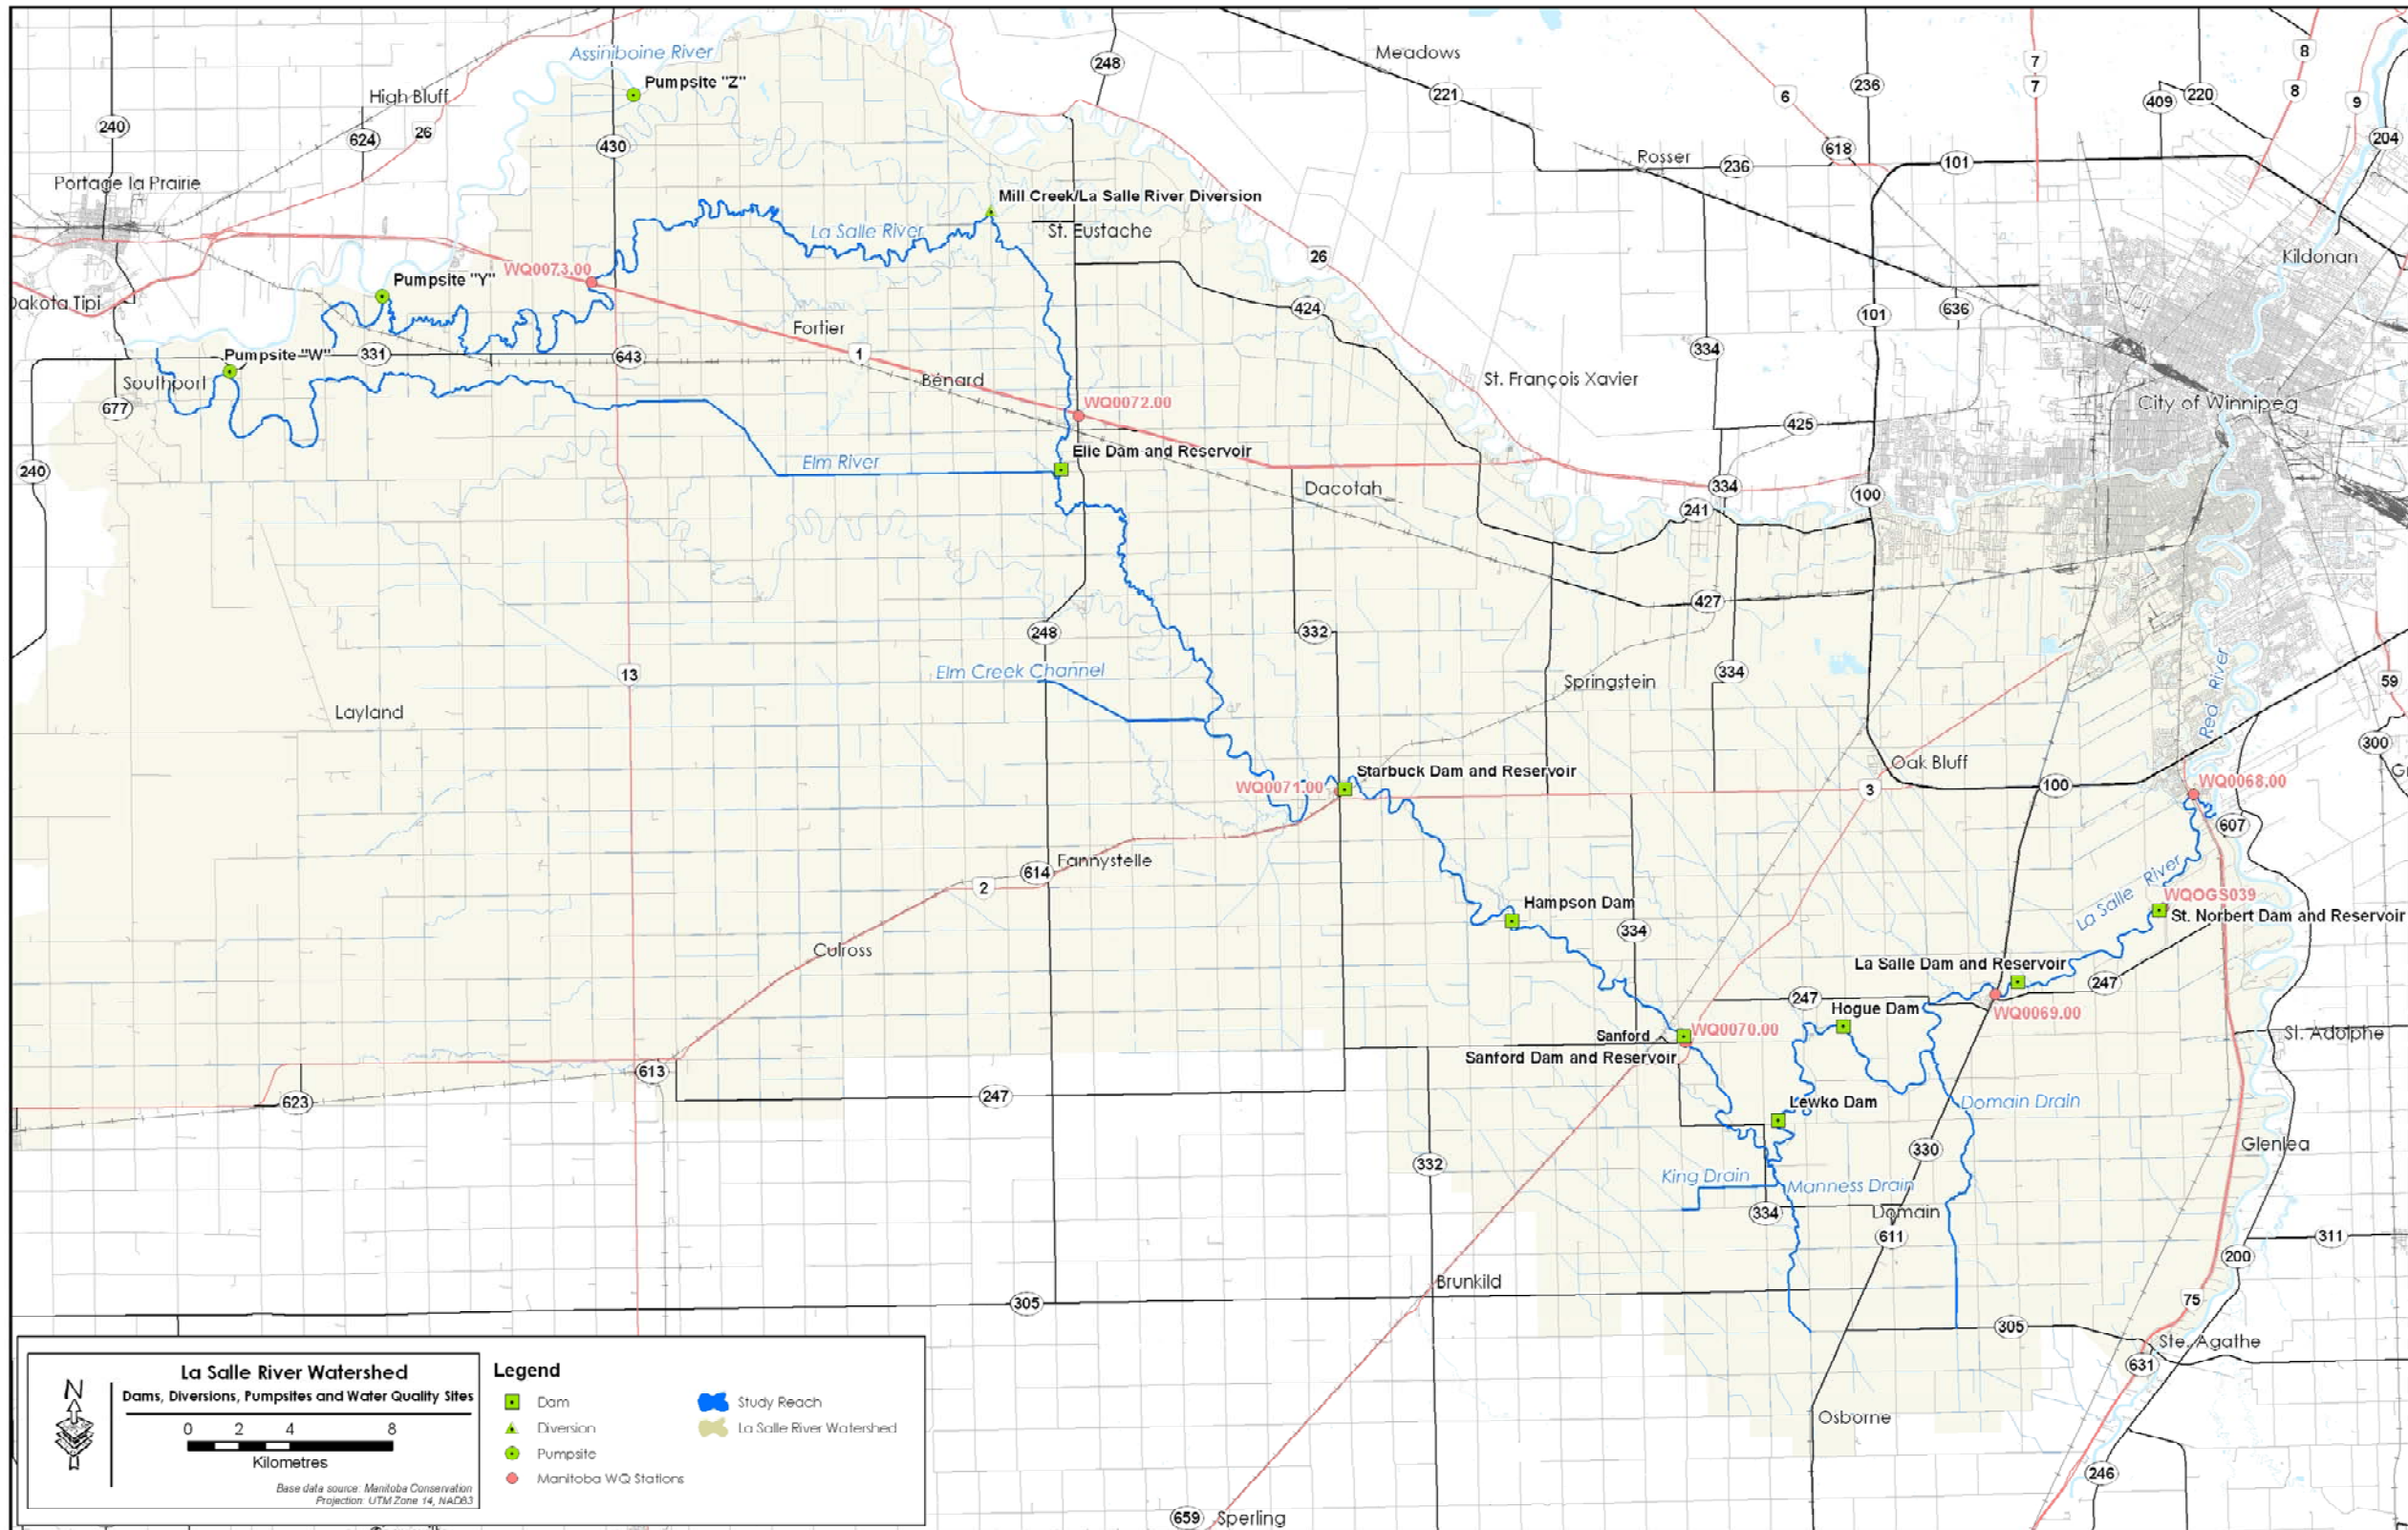
Figure 5. Location of provincial pump sites, low head dams, and Manitoba Water Stewardship – Water Quality Management sampling sites.

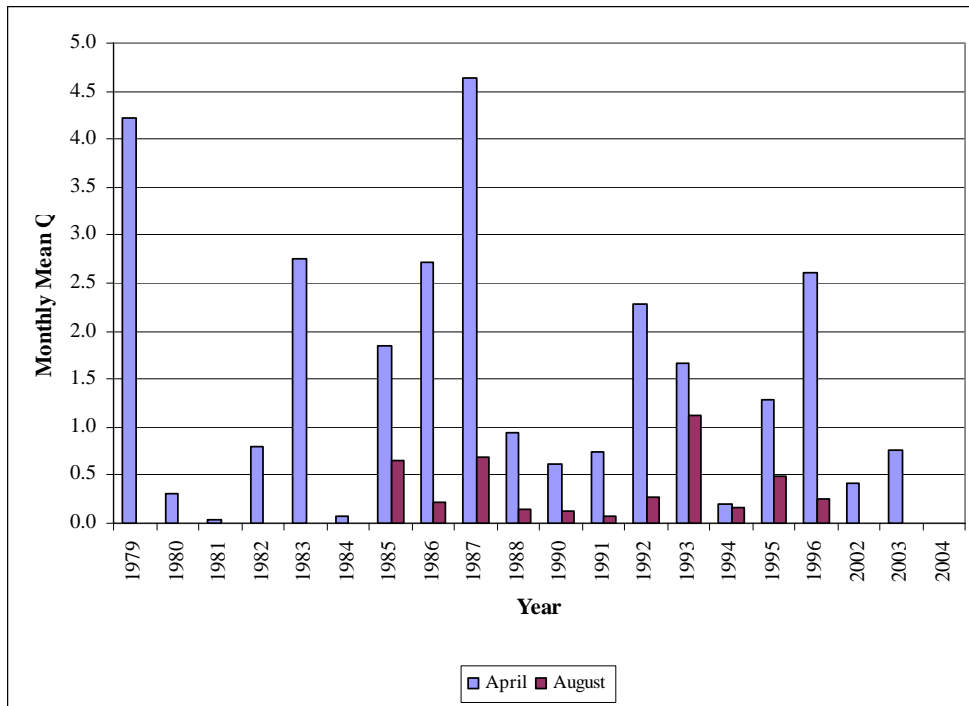
Figure 6. Mean monthly discharges in the La Salle River (Station # 050G008 near Elie) for the months of April and August, 1979 to 2004 (Source: Environment Canada, Water Survey of Canada).

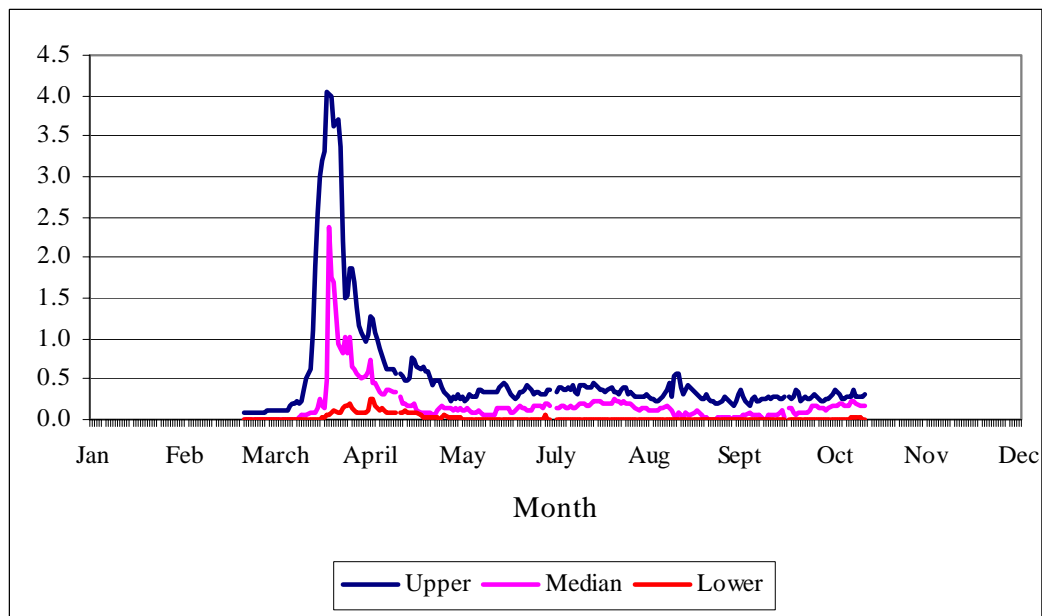
Figure 7. Median, upper and lower daily quartile flows for the La Salle River (Station # 050G008 near Elie) from 1979 to 2004 (Source: Environment Canada, Water Survey of Canada).

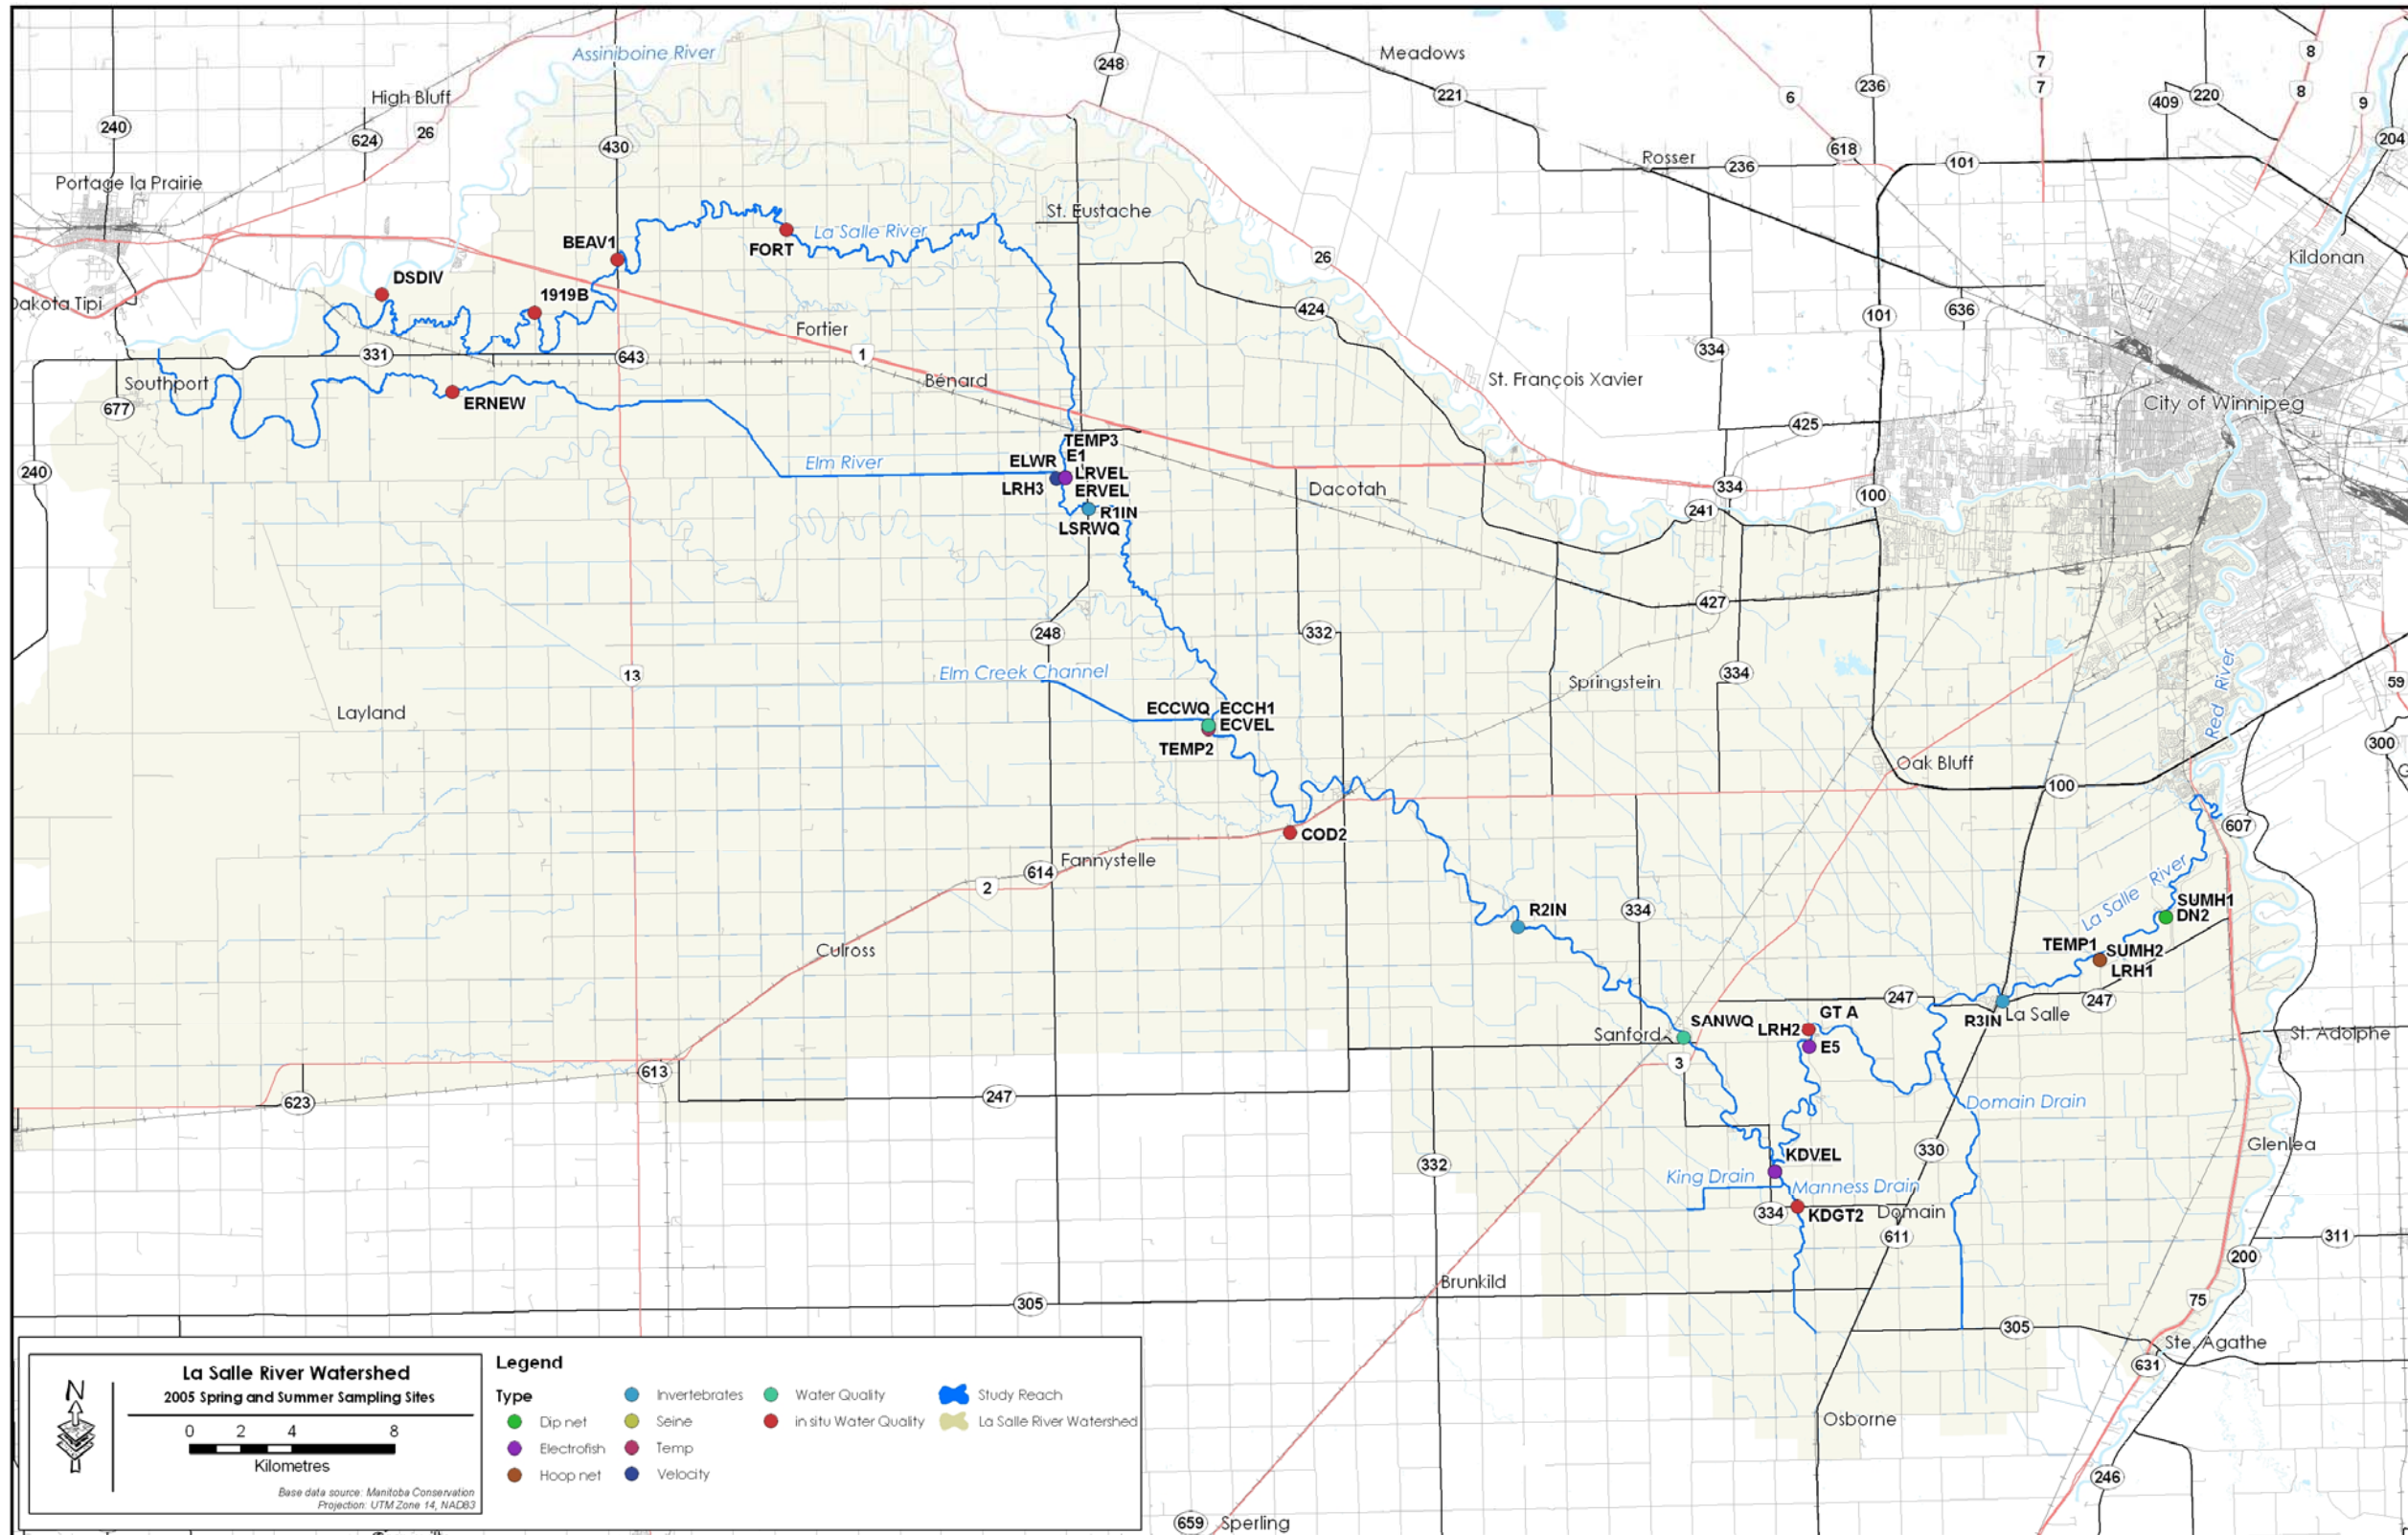
Figure 8. Hydrologic, hoopnetting, water quality, and invertebrate sampling locations throughout the La Salle River watershed, 2005.

Twenty-four fish, representing eight species, were captured at LRH1 (~ 13 km upstream from the mouth) (Table 8, Figure 8). These were: black crappie (n = 7); carp (n = 4); northern pike (n = 4); shorthead redhorse (n = 3); quillback (n = 2); and white sucker (n = 2). One each of bigmouth buffalo and freshwater drum were also captured. Six female and one male black crappie were preparing to spawn in the current year; two male carp were preparing to spawn in the current year; and one female northern pike was preparing to spawn while one had already spawned in the current year (Appendix 4). Three of the suckers captured (i.e., shorthead redhorse and white sucker) were spent males, while one was a ripe female. The big mouth buffalo, measuring 511 mm, did not show any sign of current year reproductive activity.

Two northern pike (one a spent male) and one black crappie (preparing to spawn) were captured at LRH2 (~ 34 km upstream from the mouth) (Table 8, Figure 8, and Appendix 4).

Ninety-one fish, representing five species, were captured at LRH3 (~ 102 km upstream from the mouth) (Table 8, Figure 8). The majority of these were black bullheads (n = 74) followed by white sucker (n = 11). The remainder of the catch was comprised of three northern pike, two black crappie, and one carp. Five male and four female white suckers captured were preparing to spawn in the current year. Sex and state of maturity were not obtainable from either the northern pike or black crappie (Appendix 4).

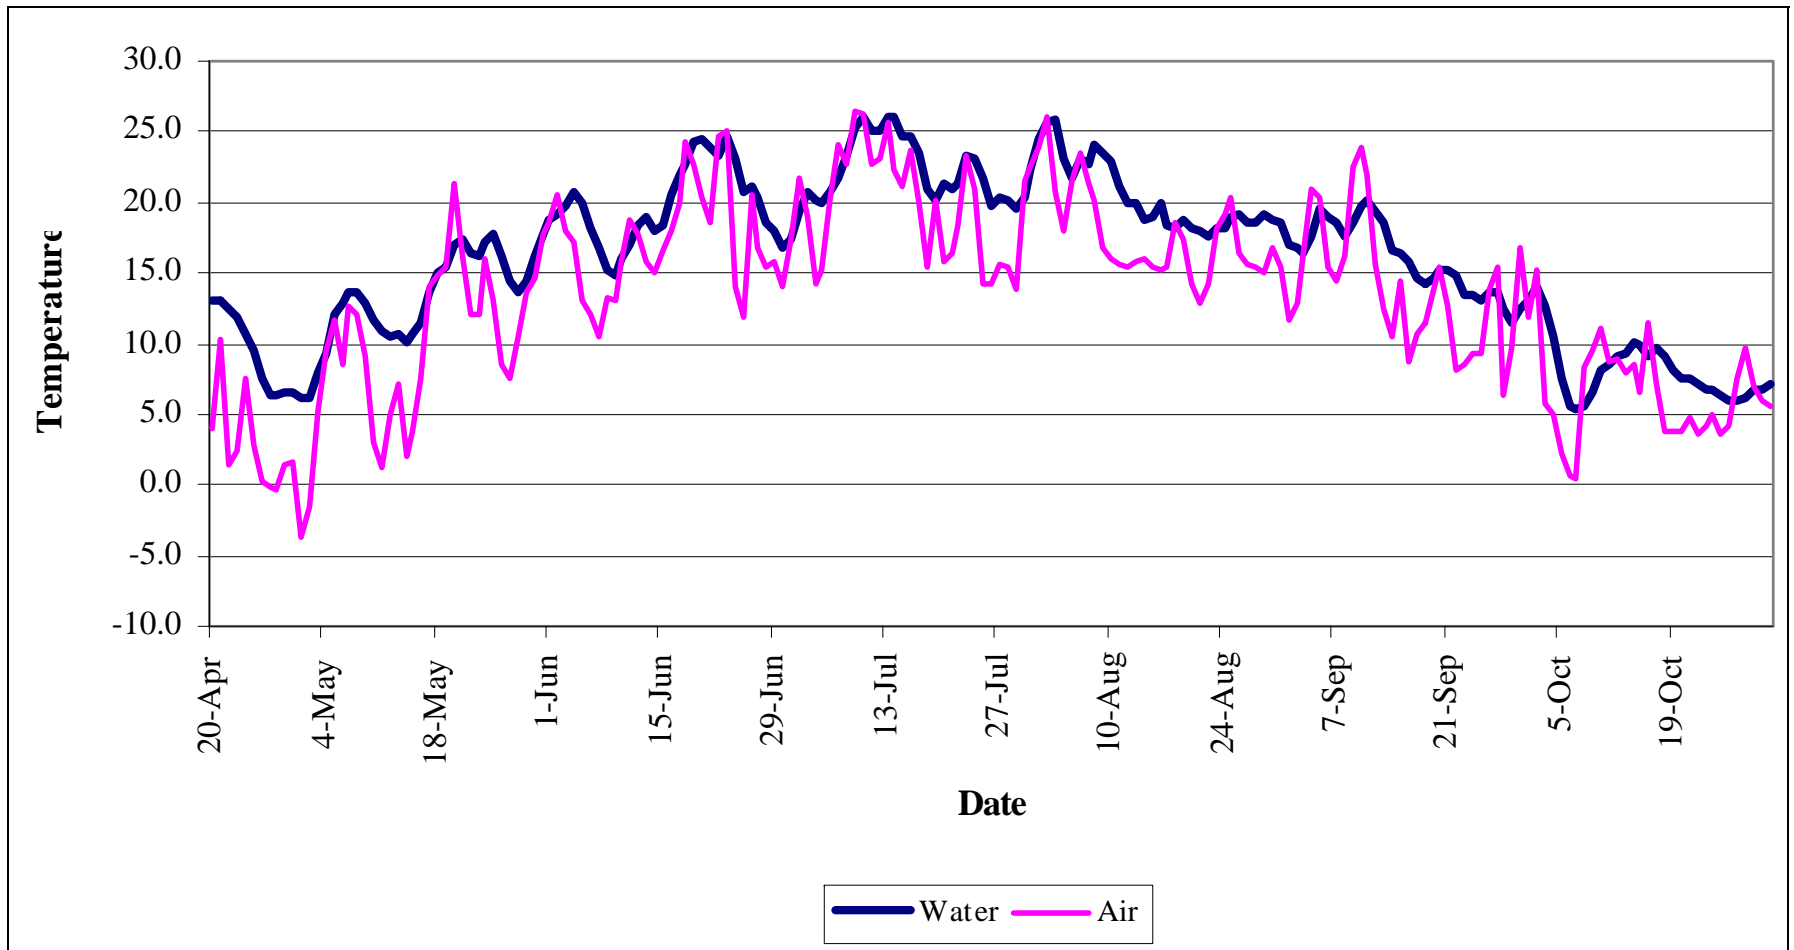
Figure 9. Mean daily water (TEMP3 at the La Salle River) and air temperature ($^{\circ}\text{C}$) data recorded from April 20 to November 1, 2005. Mean daily air temperatures recorded at Winnipeg by Environment Canada (ECCWO 2006).

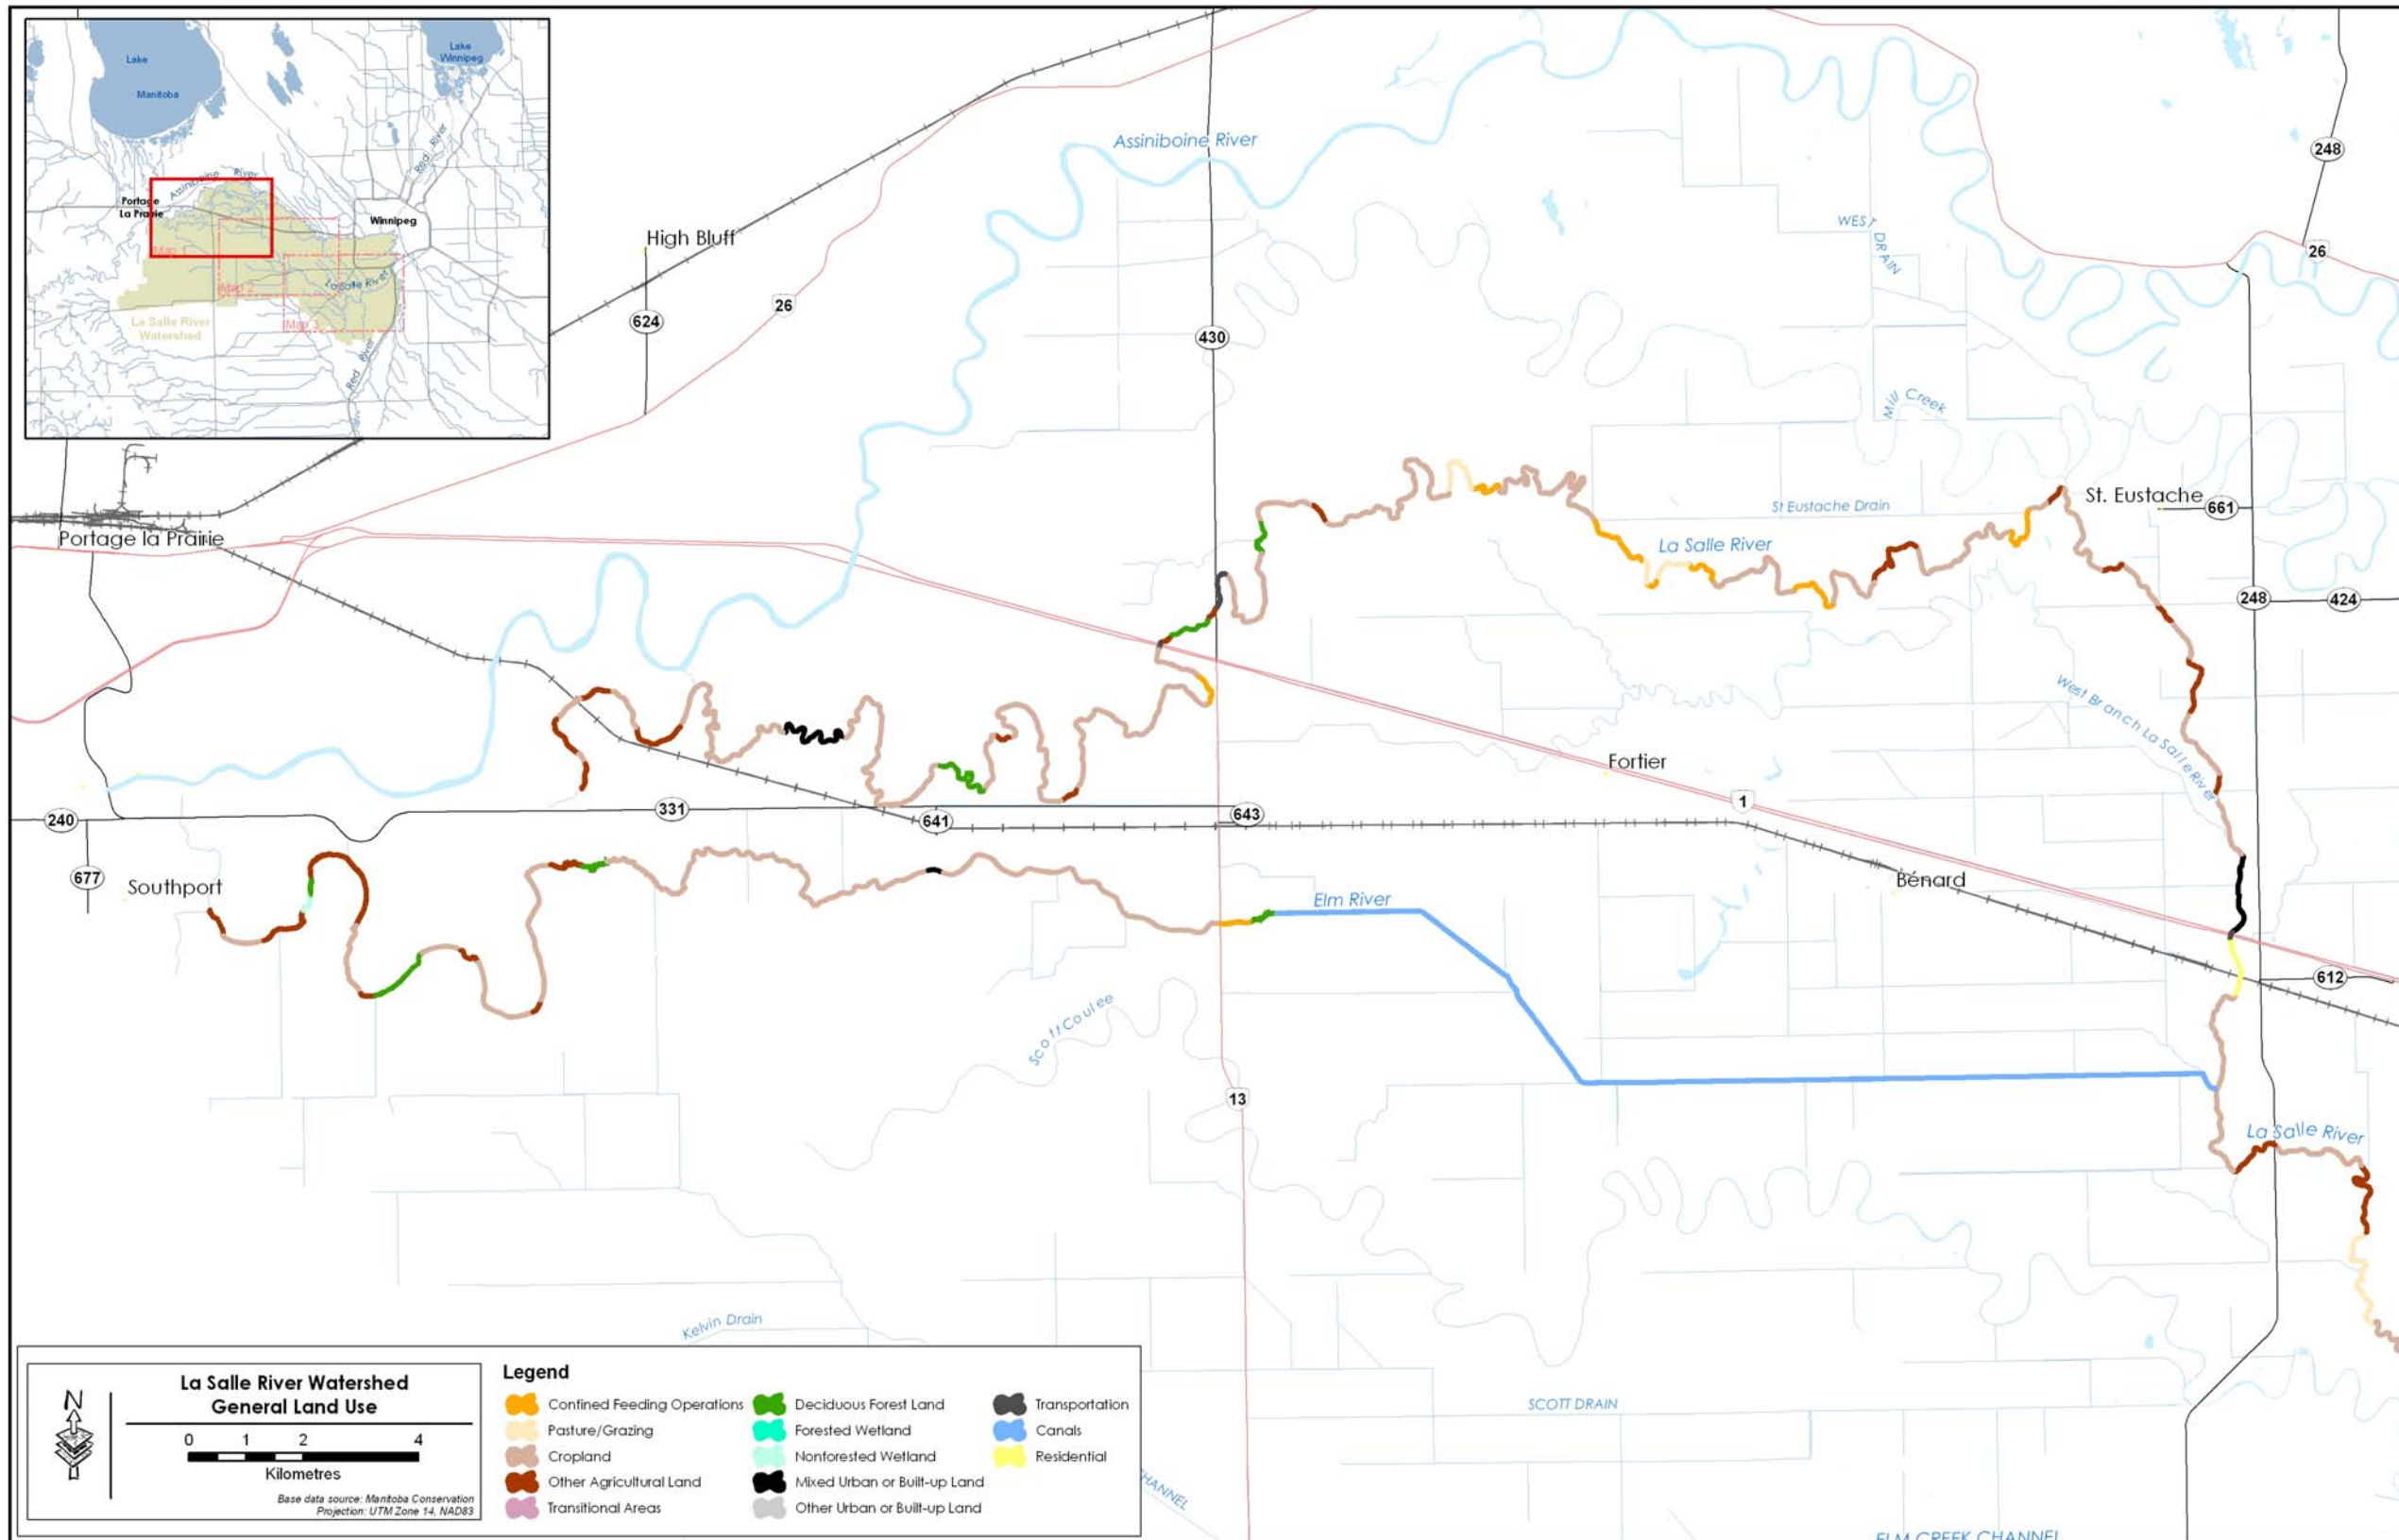
Figure 10. General land use in Reach 1 of the La Salle River watershed, 2005.
