**LA SALLE REDBOINE CONSERVATION DISTRICT:
LA SALLE RIVER WATERSHED ASSESSMENT SURVEY – WITH
EMPHASIS ON LA SALLE RIVER, ELM RIVER, ELM CREEK
CHANNEL, AND THE KING DRAIN - 2005**

P. G. Graveline and J. Larter

2006

North/South Consultants Inc.
Aquatic Environment Specialists

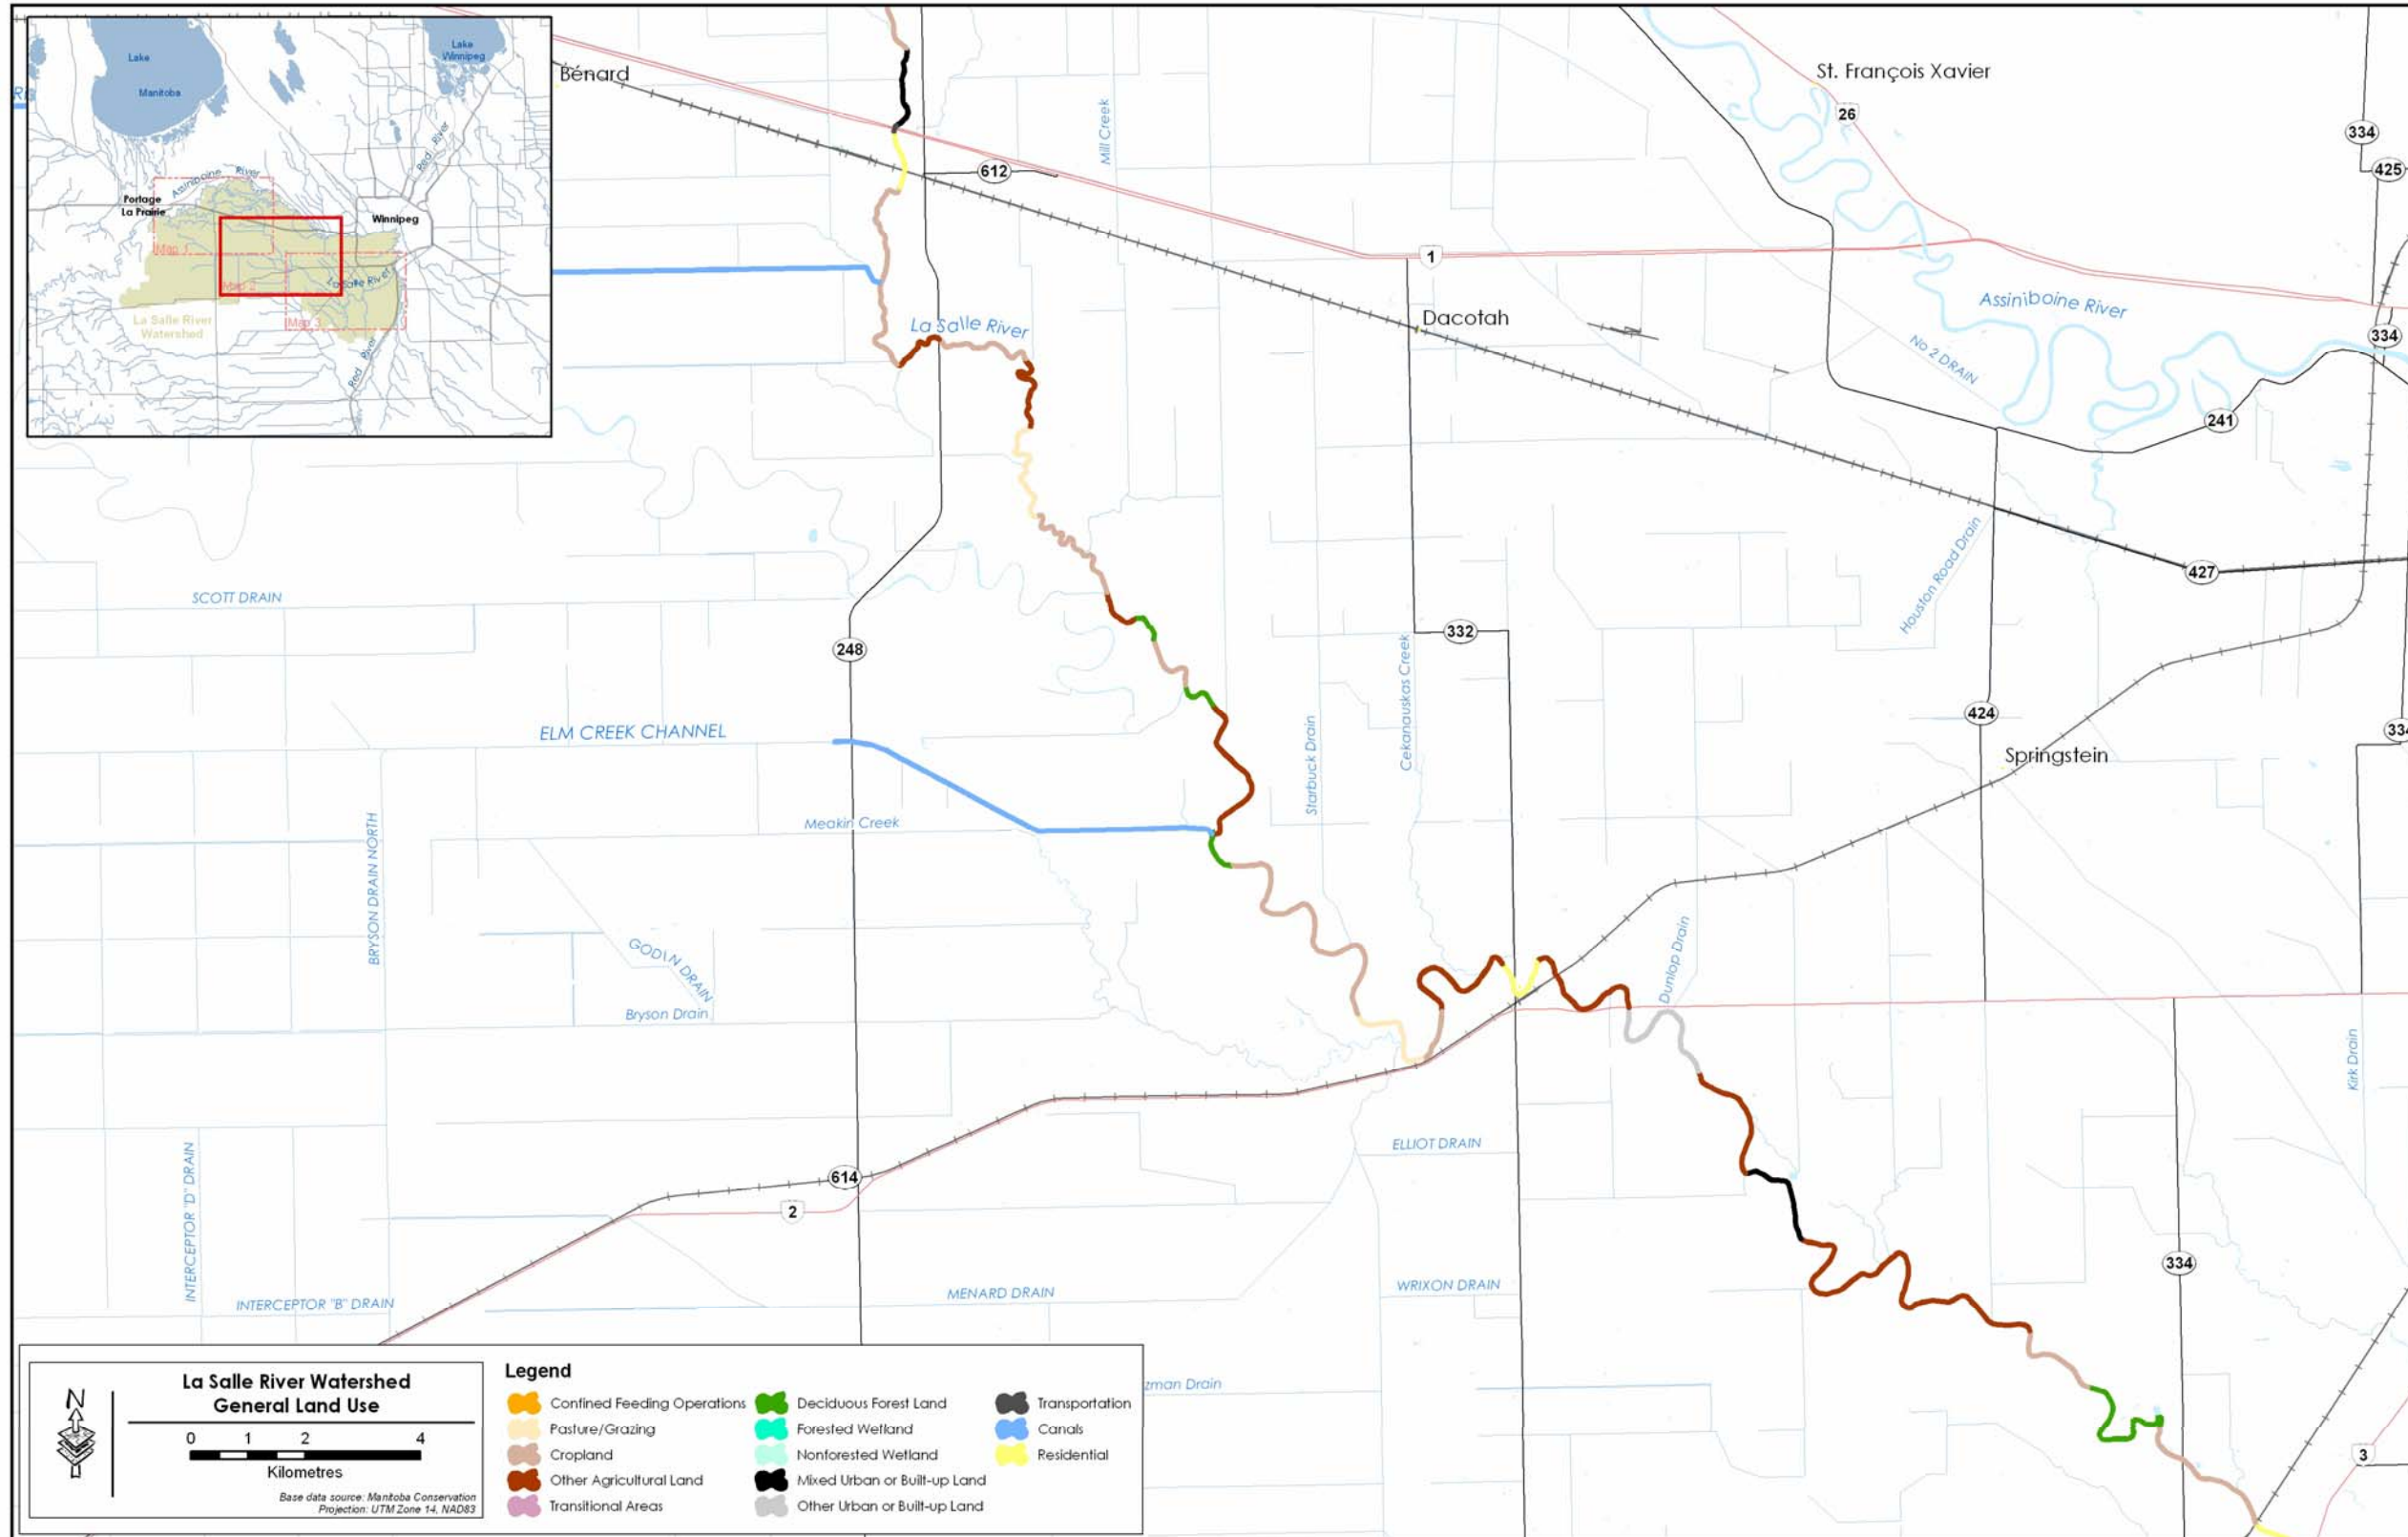
Figure 11. General land use in Reach 2 of the La Salle River watershed, 2005.

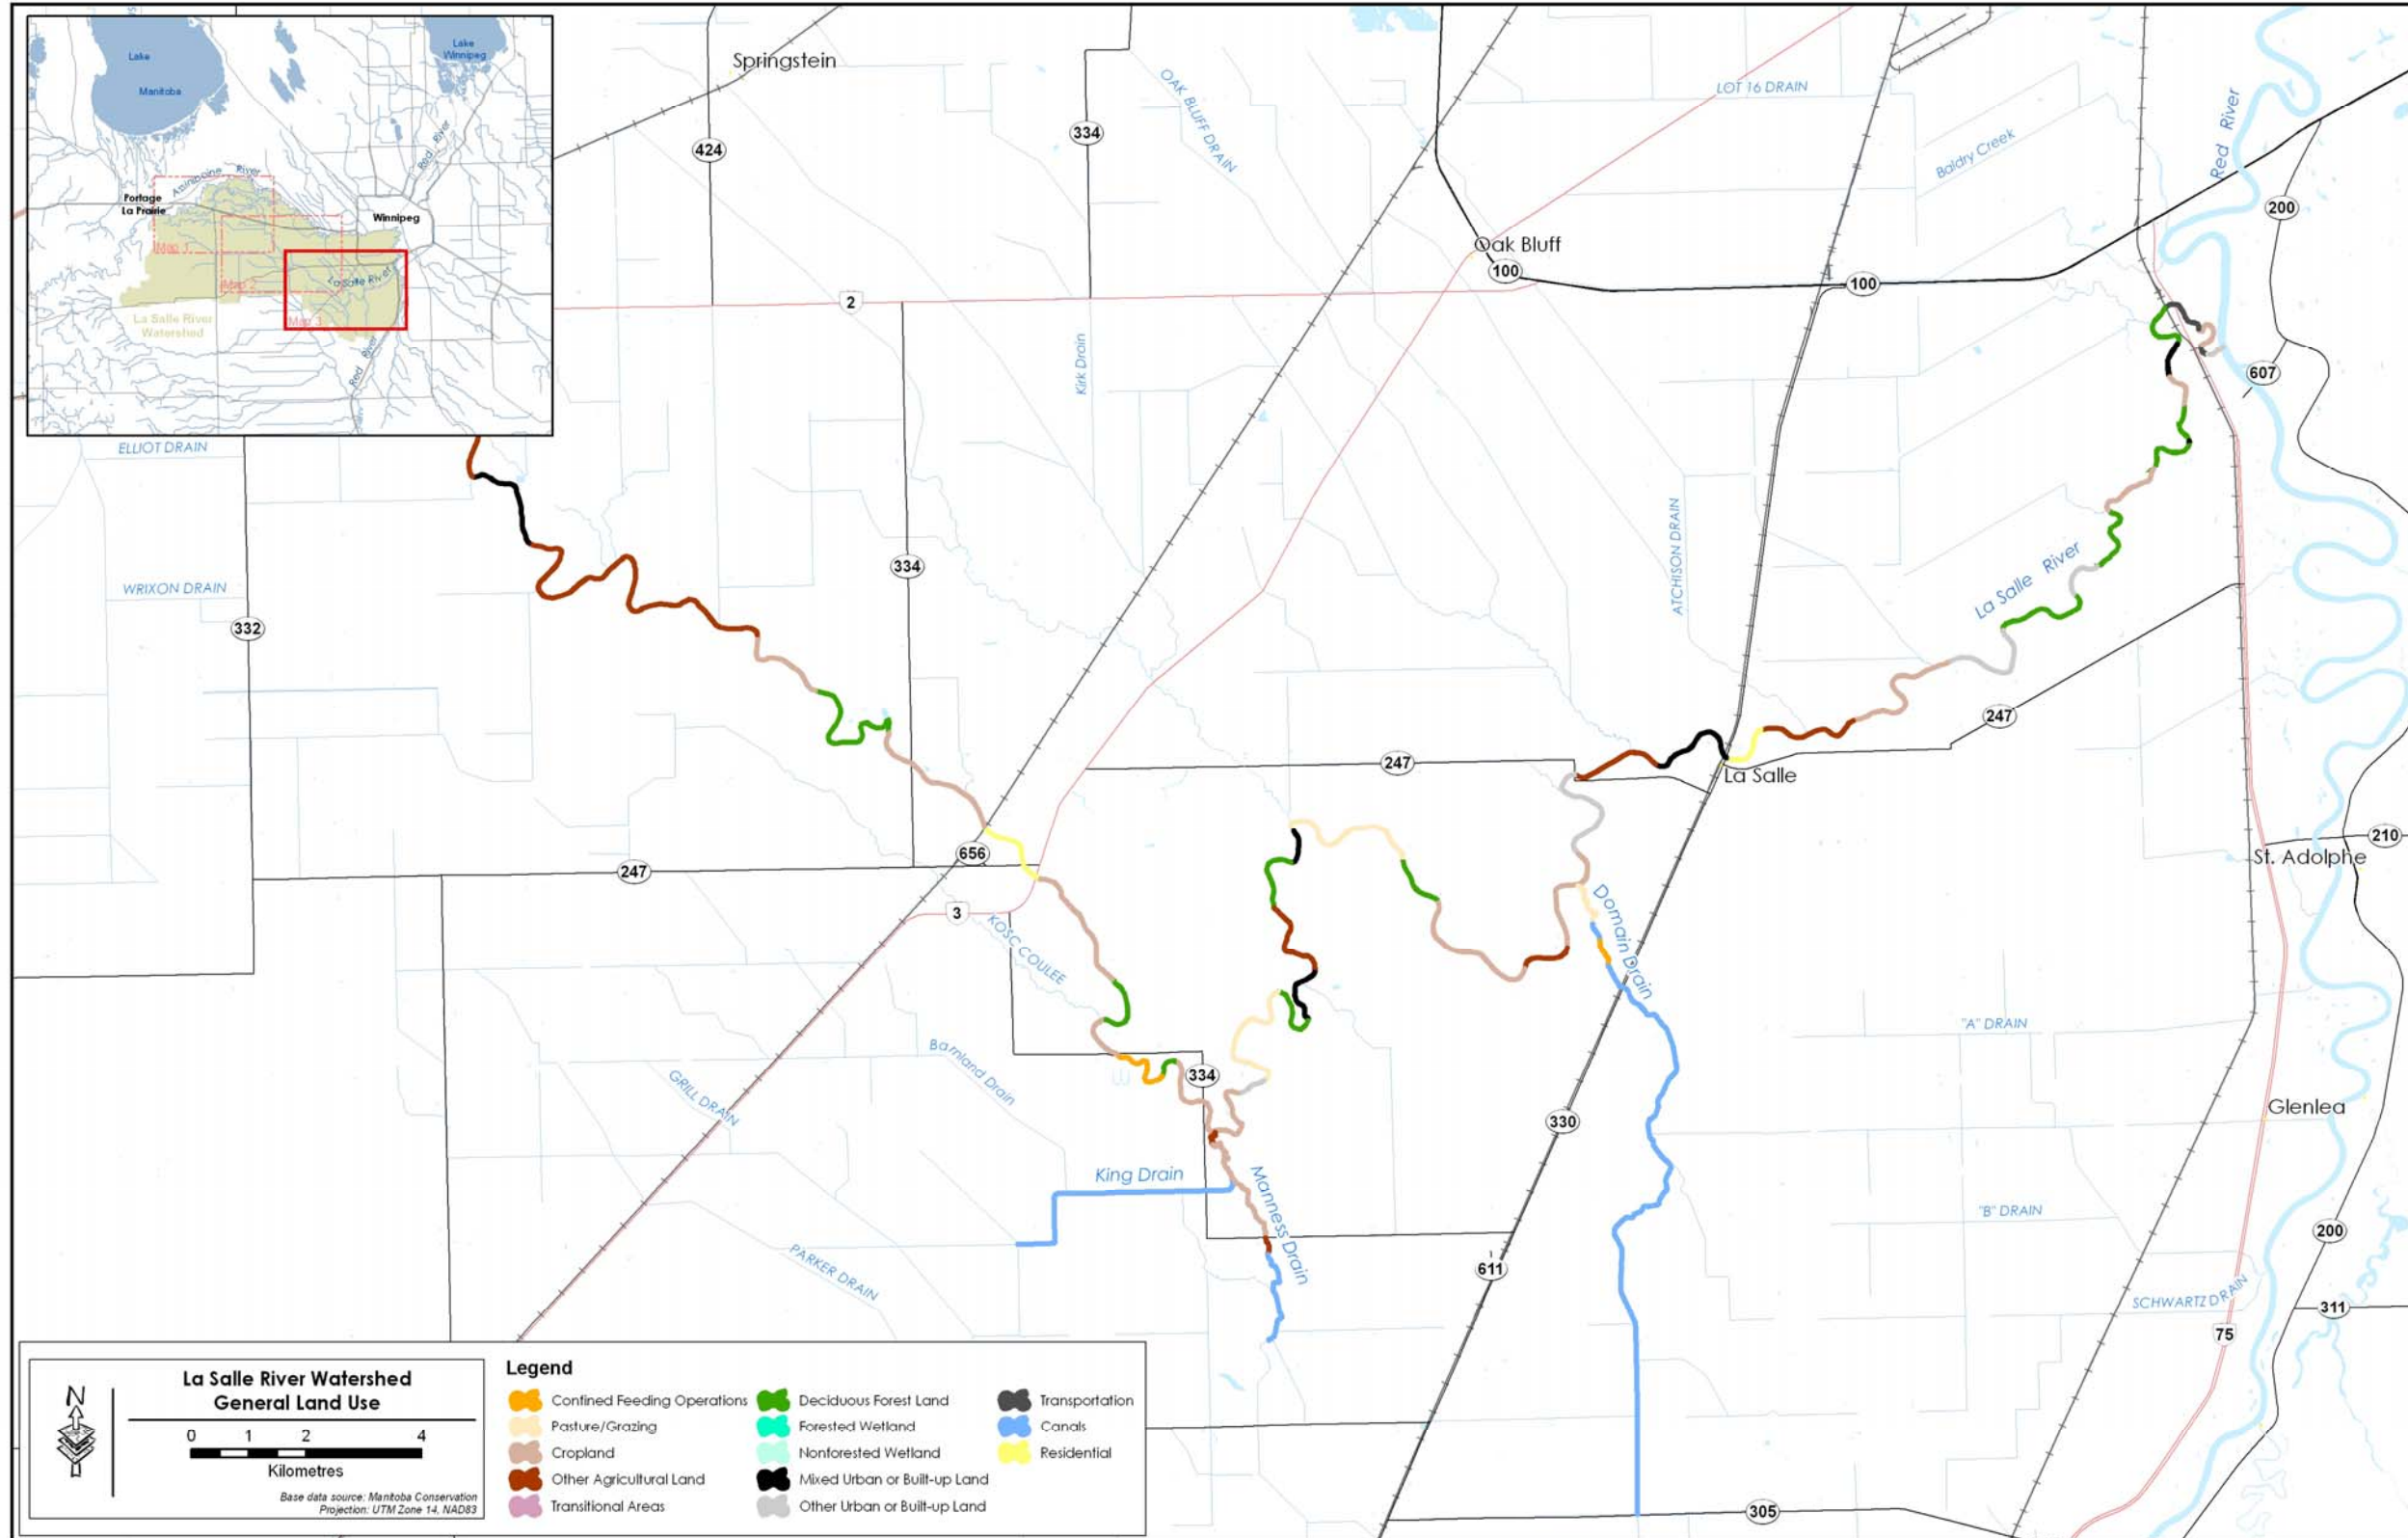
Figure 12. General land use in Reach 3 of the La Salle River watershed, 2005.

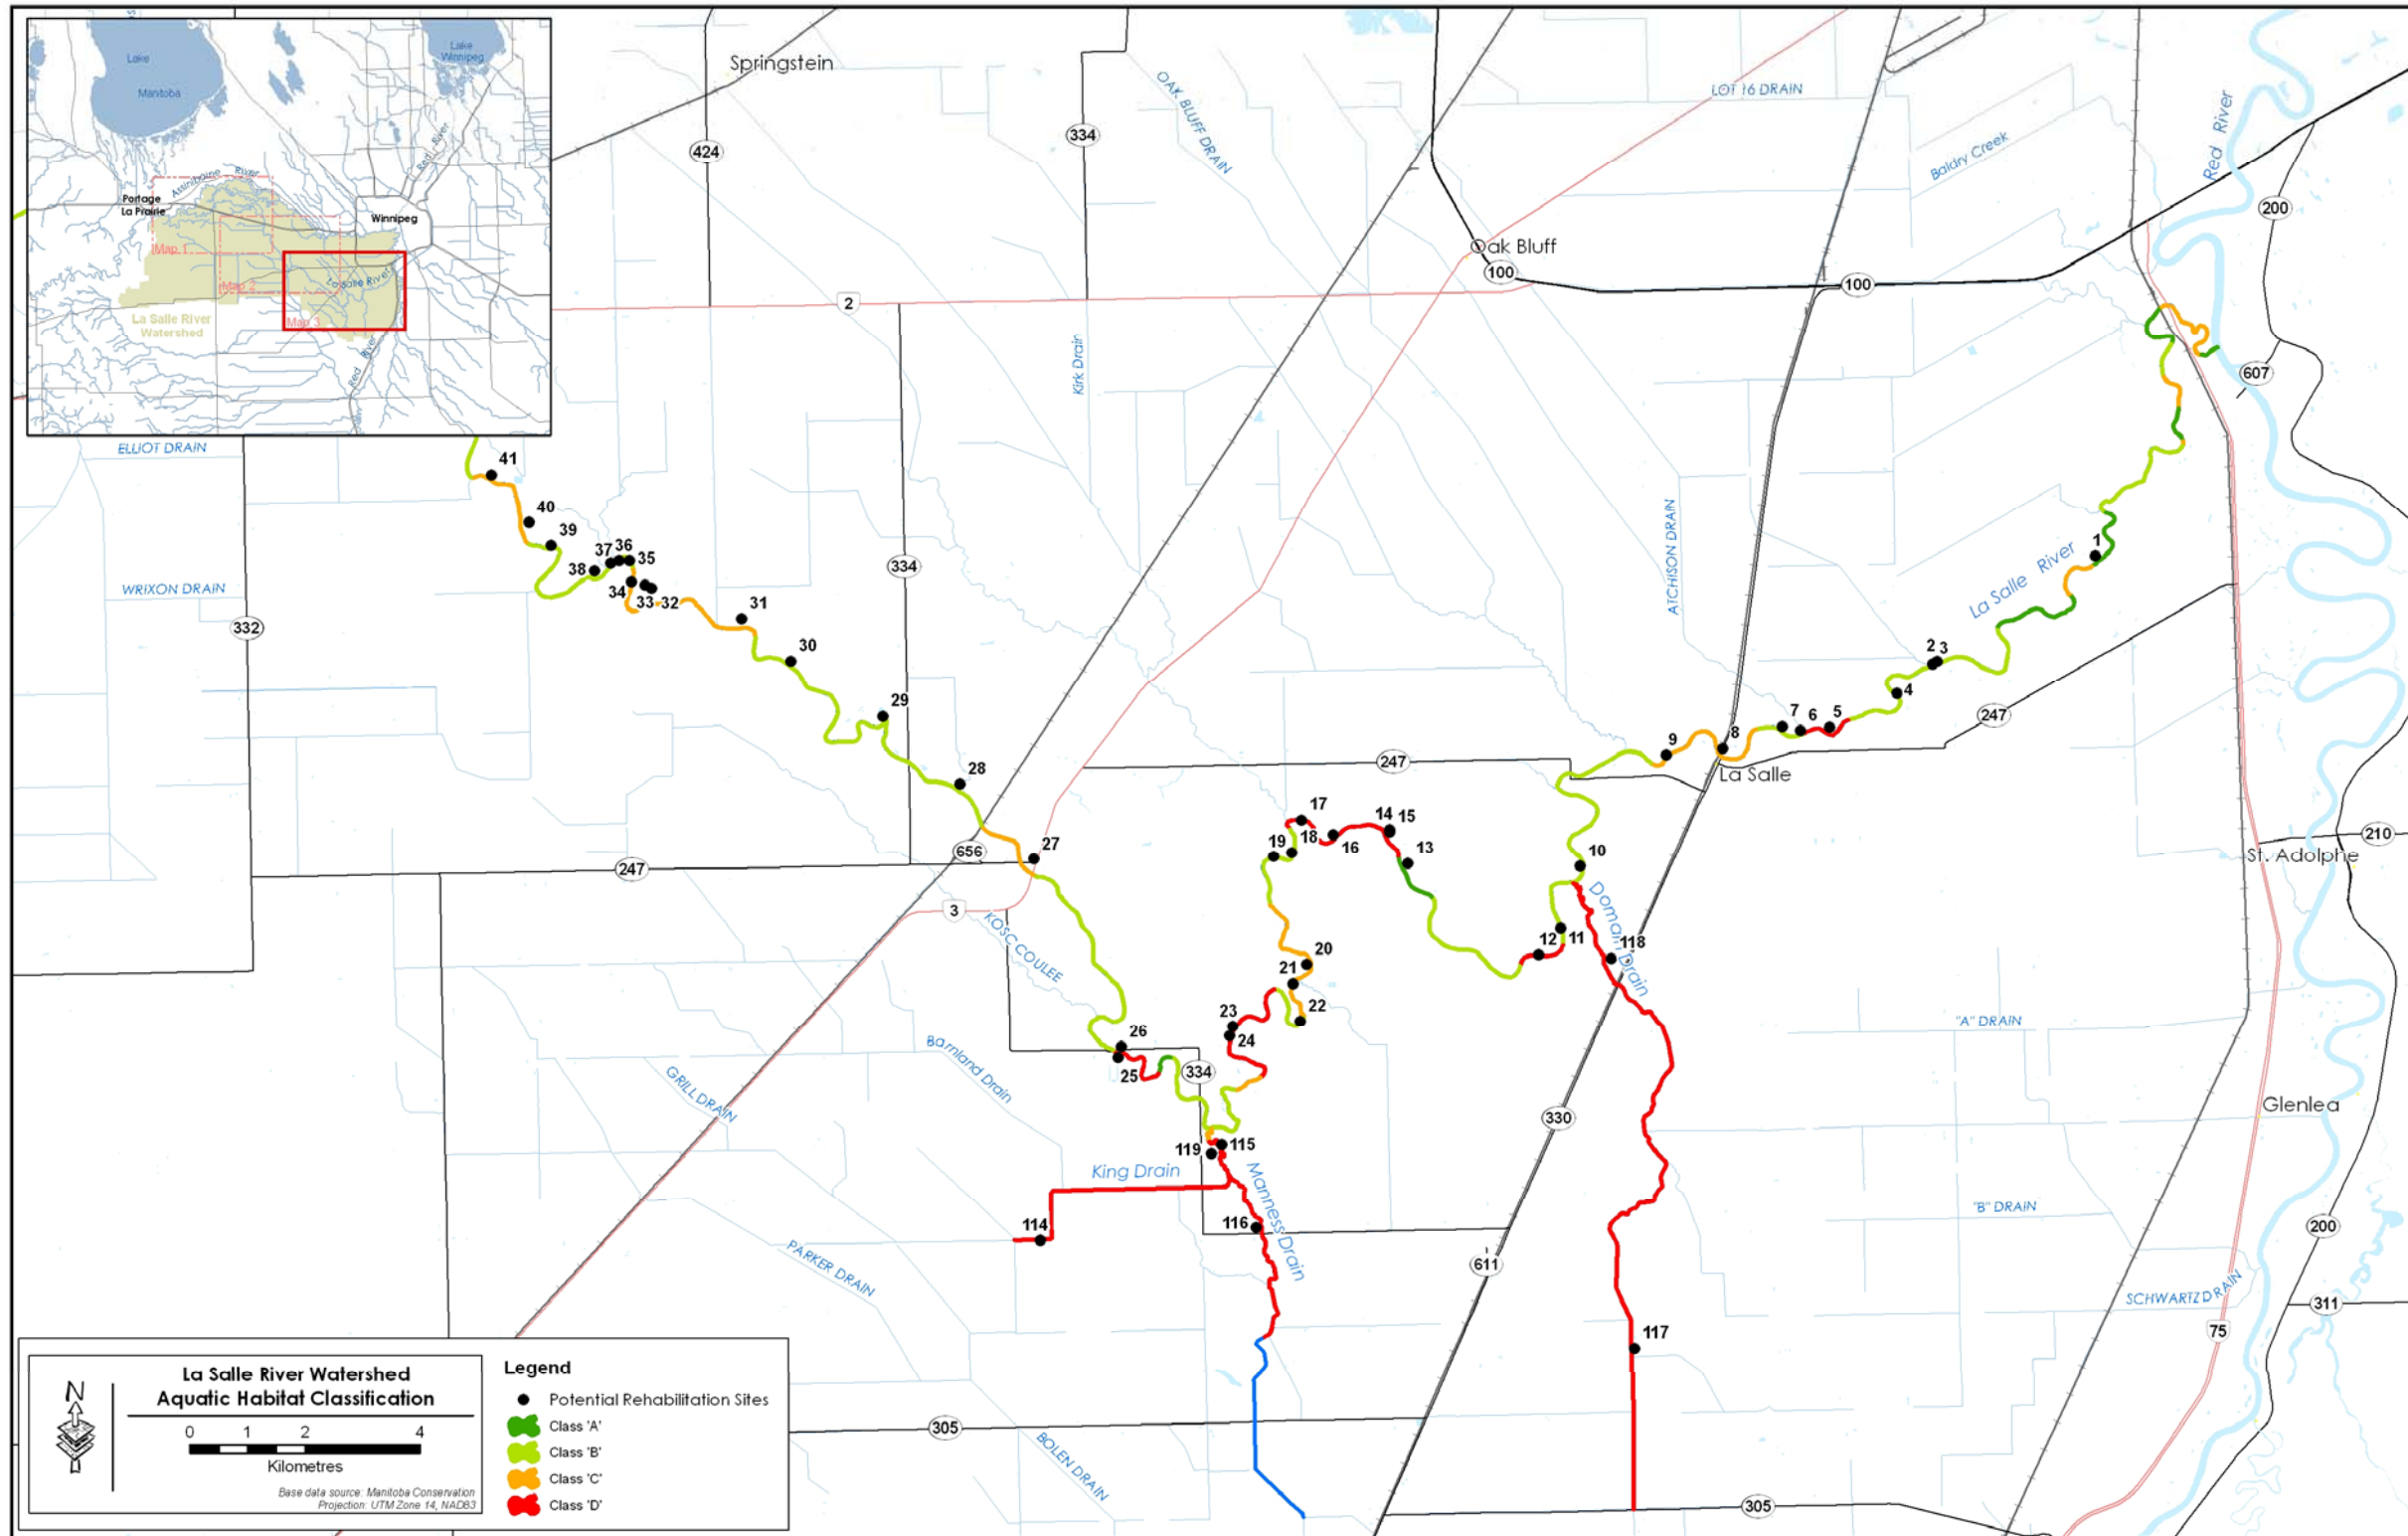
Figure 13. Aquatic habitat quality ratings and potential rehabilitation sites identified in Reach 1 of the La Salle River watershed, 2005.

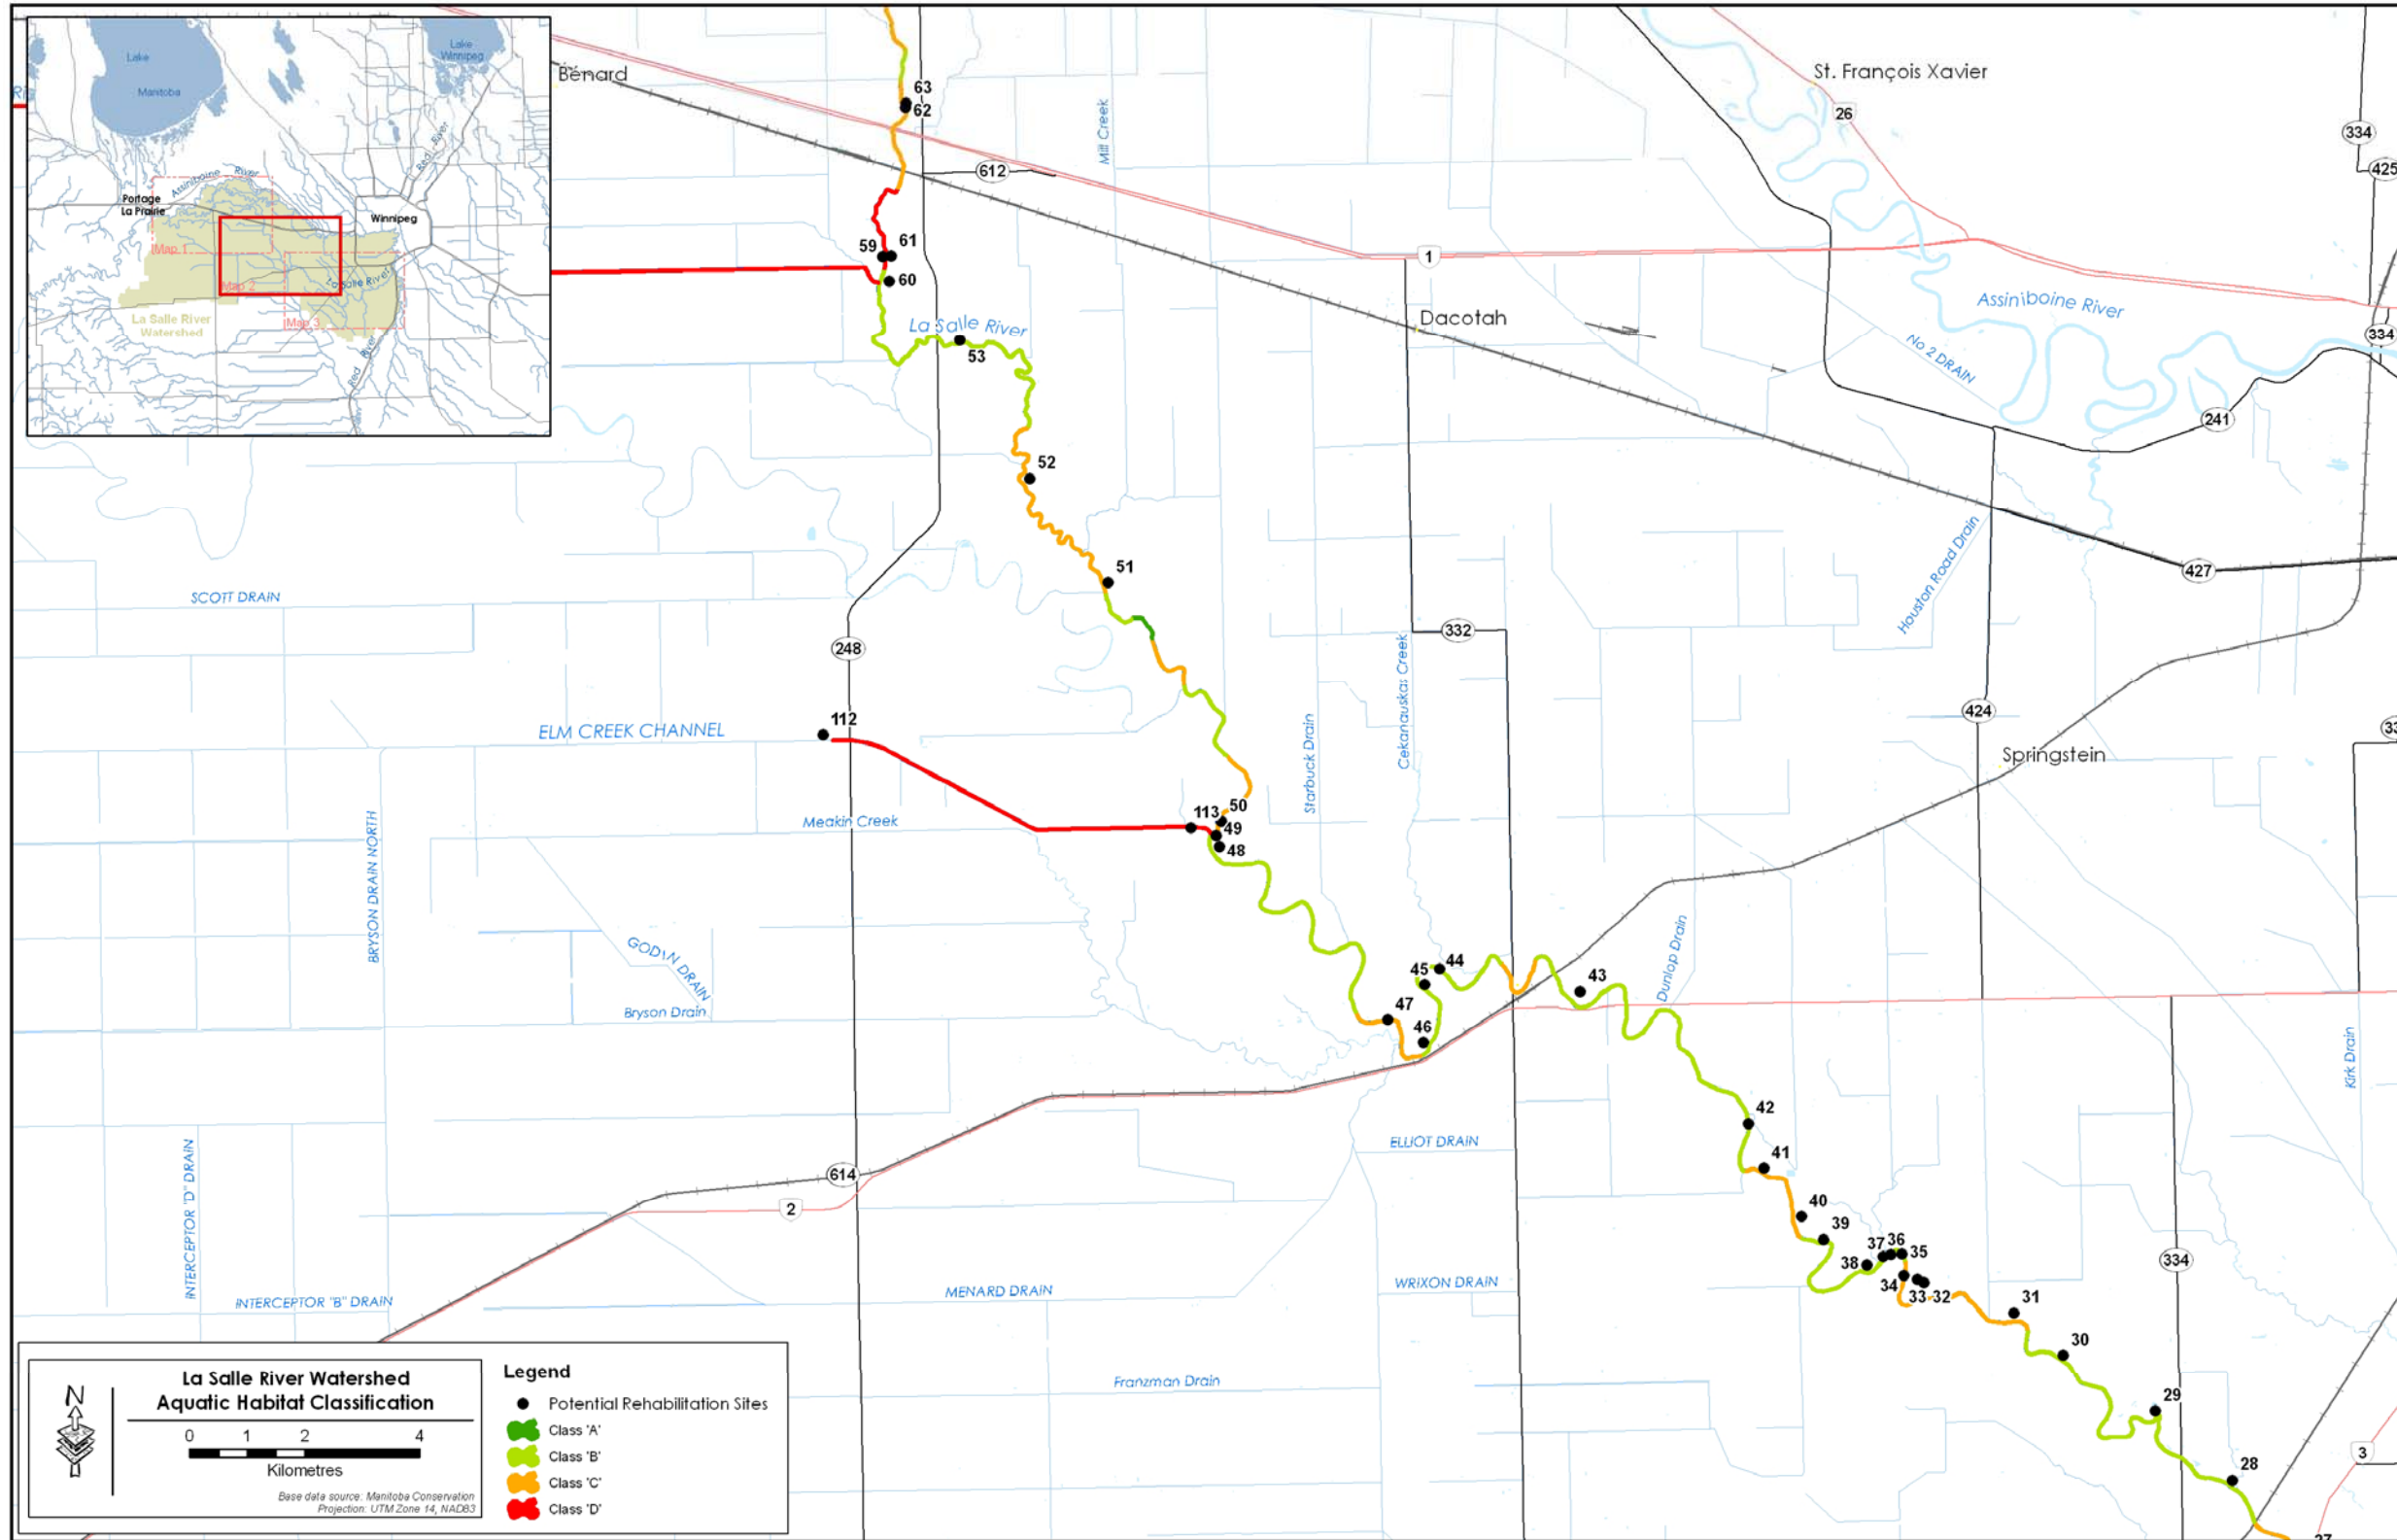
Figure 14. Aquatic habitat quality ratings and potential rehabilitation sites identified in Reach 2 of the La Salle River watershed, 2005.

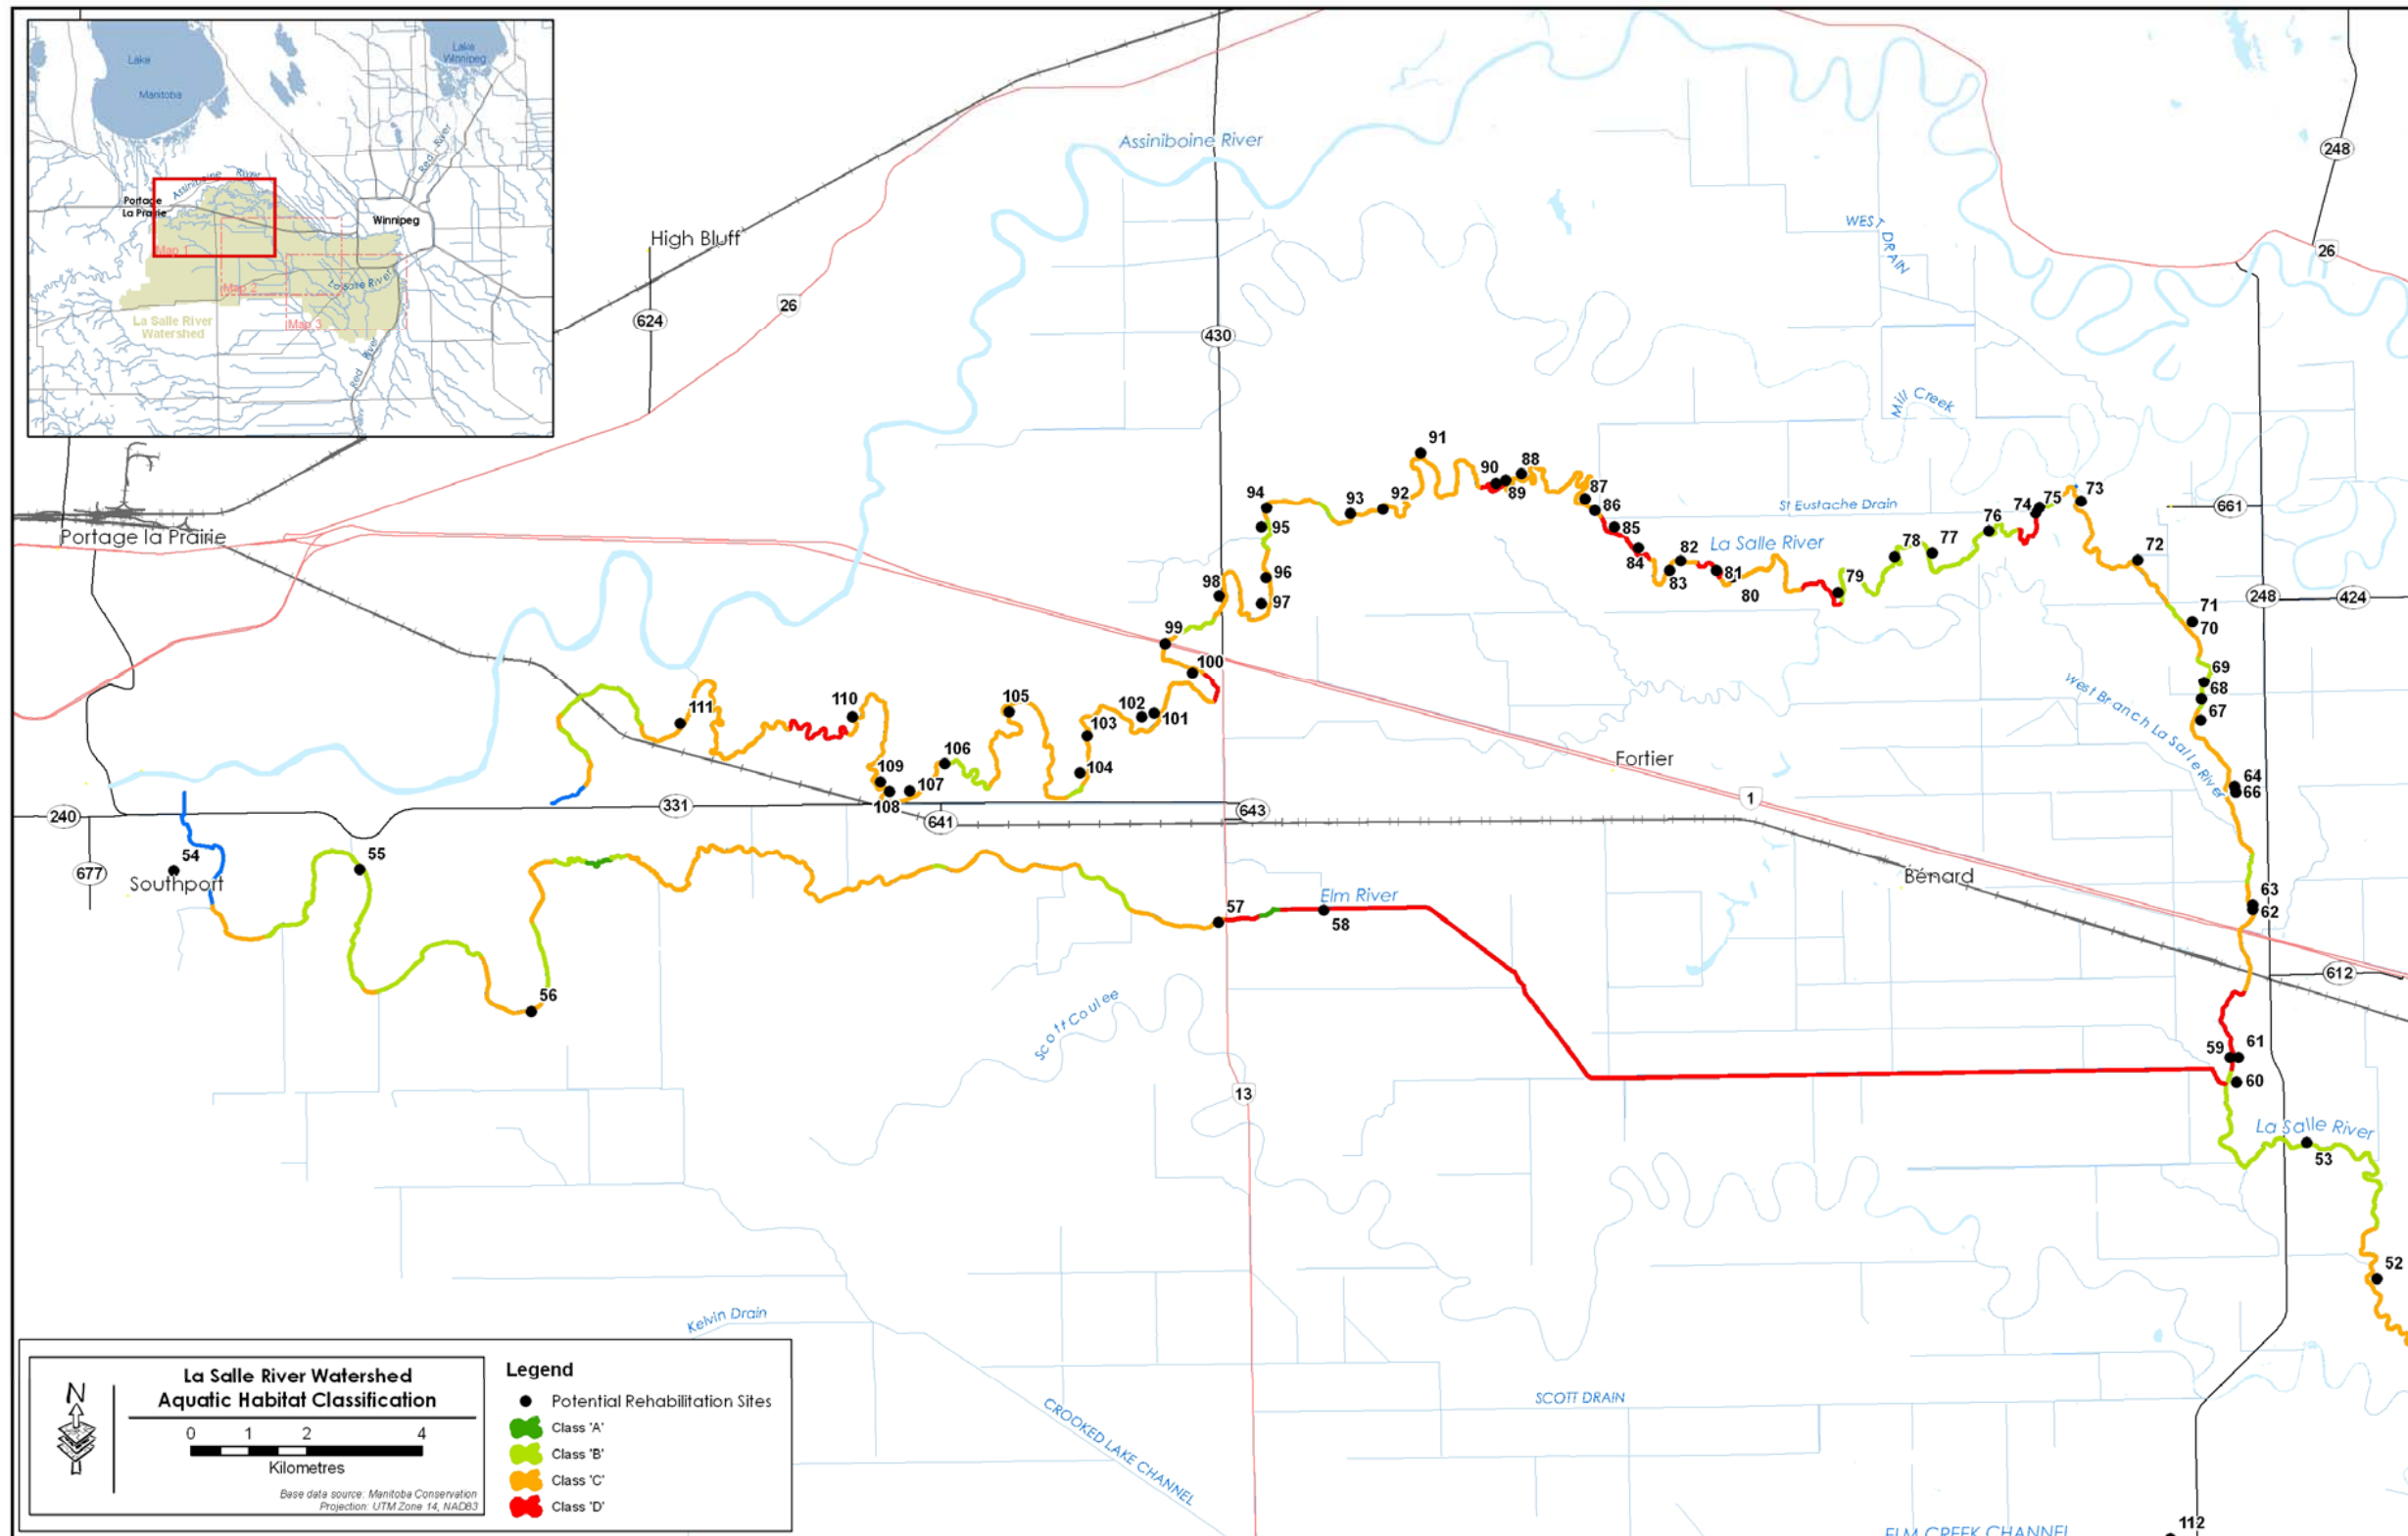
Figure 15. Aquatic habitat quality ratings and potential rehabilitation sites identified in Reach 3 of the La Salle River watershed, 2005.

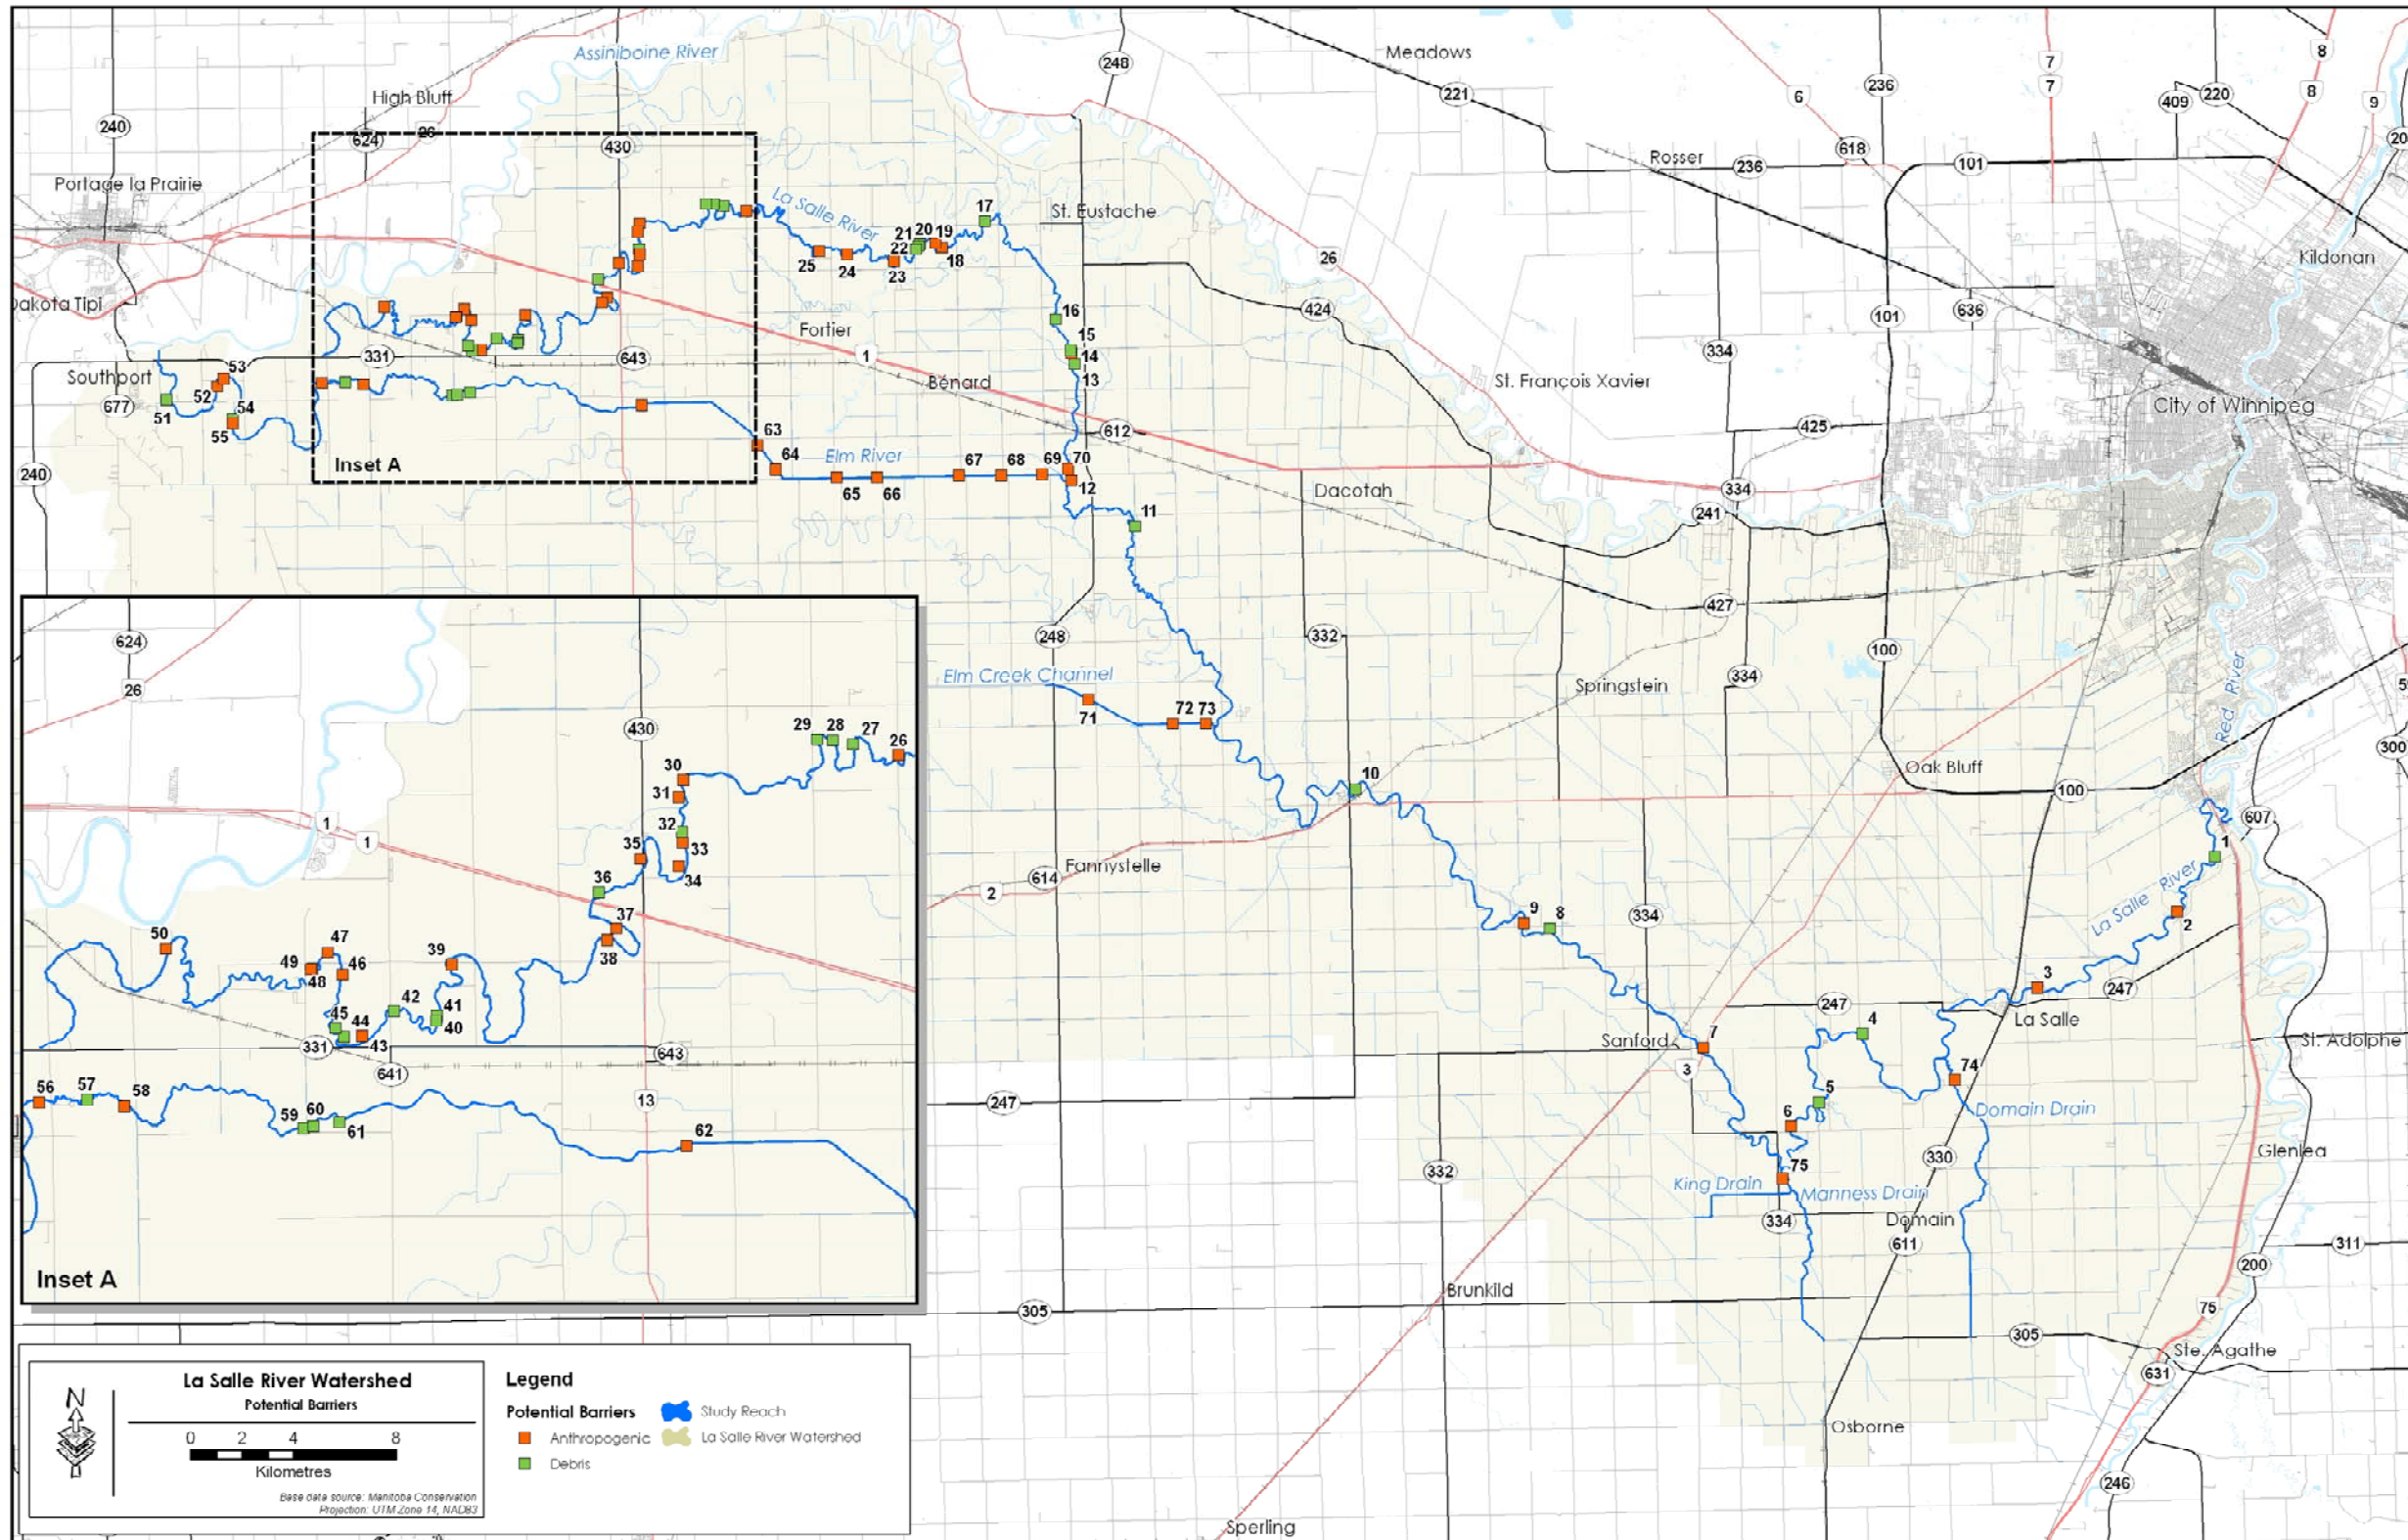
Figure 16. Potential barriers identified in the La Salle River watershed, 2005.

The majority of the anthropogenic barriers identified were ford crossings (n = 29, 64%), followed by culverts (n = 8, 18%), and low head dams (n = 8, 18%). A low head dam can be defined as a constructed barrier in a river with a hydraulic height, head water to tail water, not exceeding 8.0 m (ICF 2005). Low head dams may cause a number of biological impacts to rivers, the most obvious being a barrier to fish passage. In spring, these can be complete barriers at low water levels or act as velocity barriers at higher flows. Conversely, downstream migrations can also be impaired at some flows or as a result of plugged outlets (e.g., young of year carp captured on King Drain). Less obvious impacts that can be caused by dams include: changes in aquatic and terrestrial habitat; changes in hydraulic regimes upstream; reducing the flow of water required by wetlands or riparian areas downstream; and changes to water quality of the stream (Anonymous, circa 1994; www.axelfish.uoguelph.ca/research/BILD; www.epa.gov/owow/nps/MMGI/Chapter6).
